# **A survey for the effect of 2011 Van earthquakes on elevators**

**Prepared by  
Professor C.E.İmrak**

**January 2012**

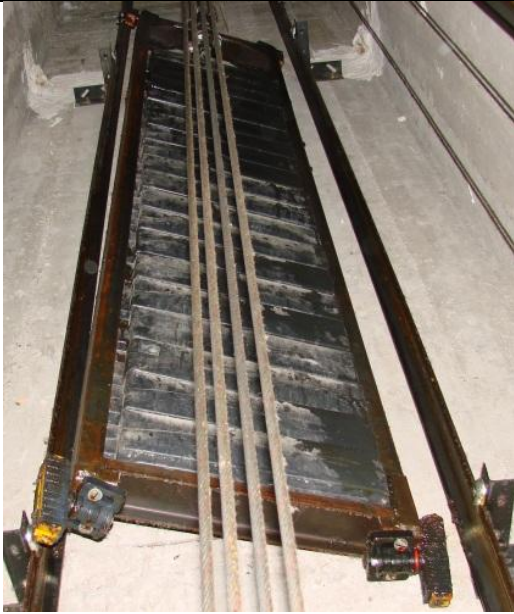
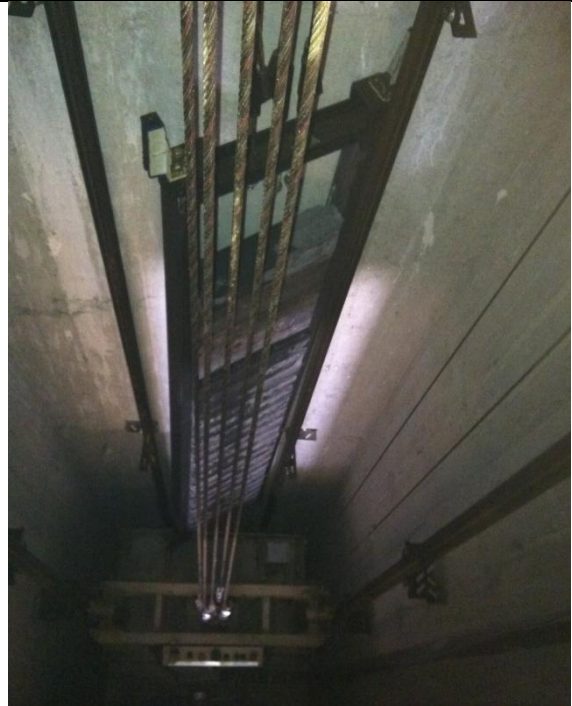
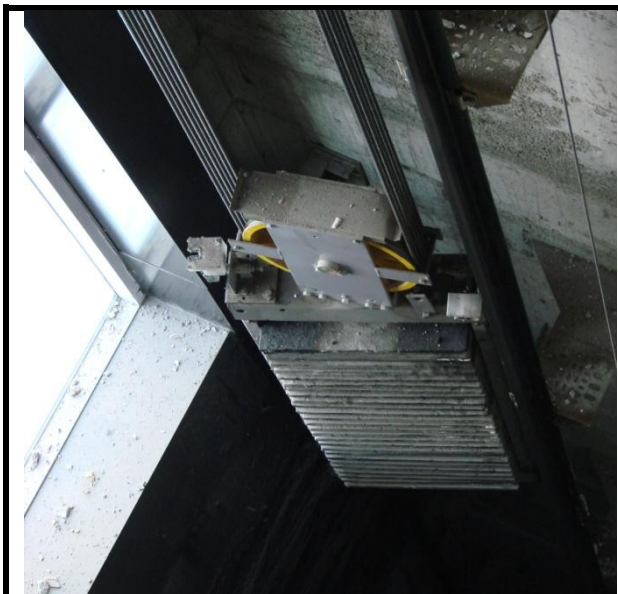
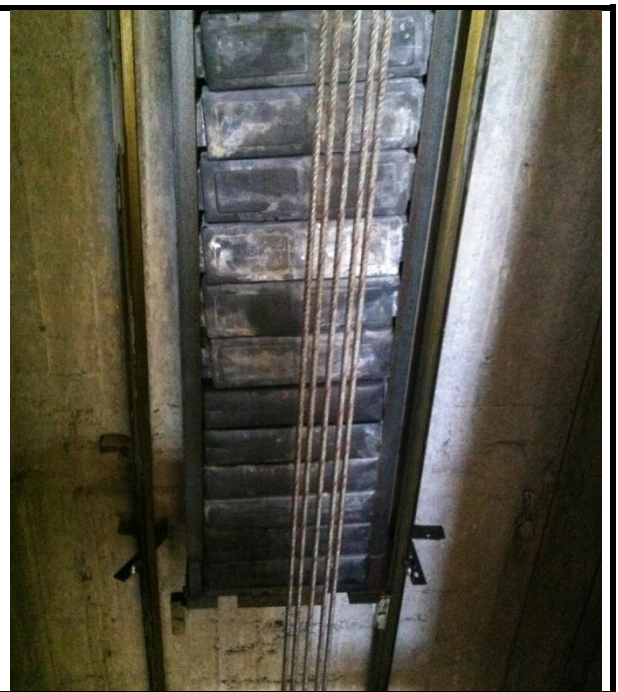
- In general, the view of all visits, the counterweights of the traction machines and MRLs came out of their guide rails. The main reasons for derailments were larger bracketing spans and insufficient installation practice that caused bent rails and brackets, and broken guide shoes.

Counterweights out of their guide rails

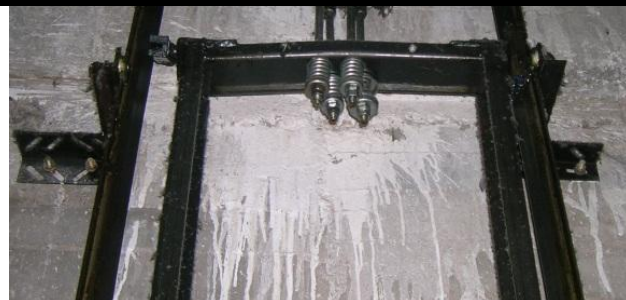
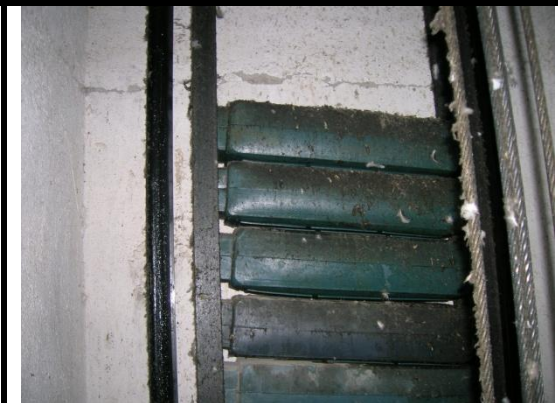
**Counterweight frame bent**

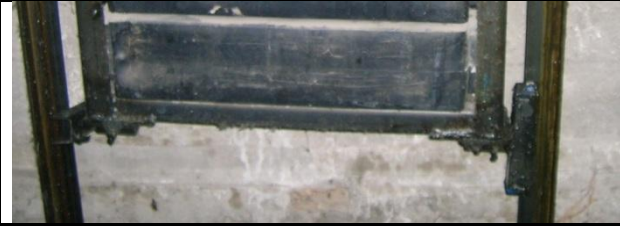
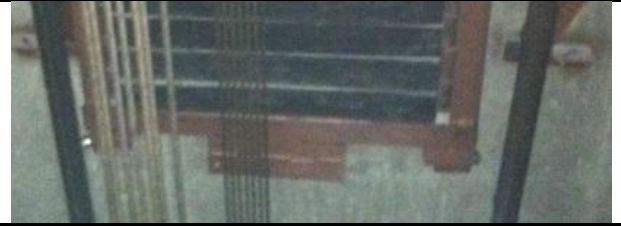
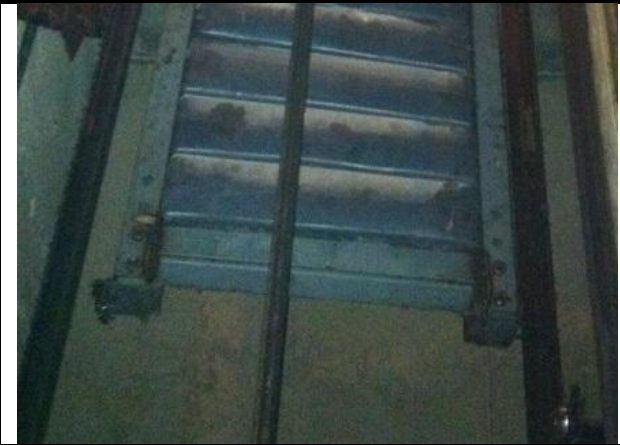
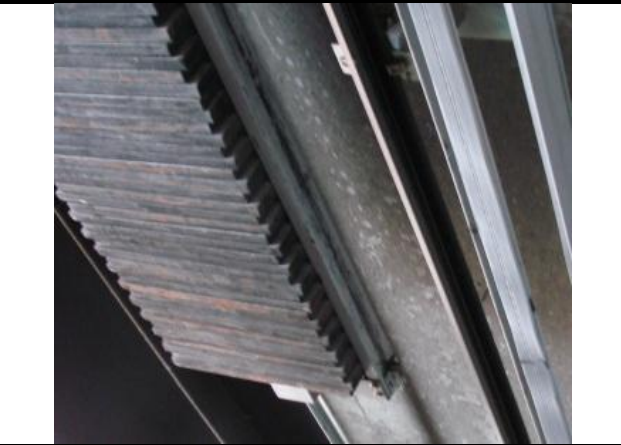
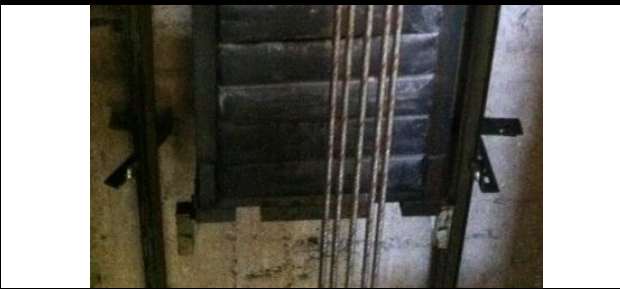
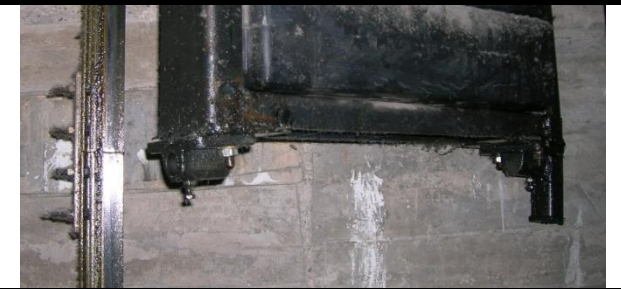
Guides broken or loose

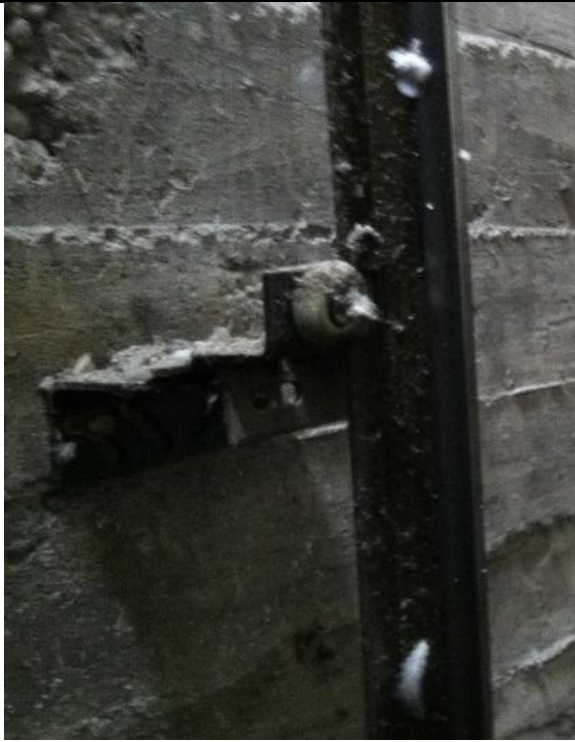
**Bent guide rail brackets**

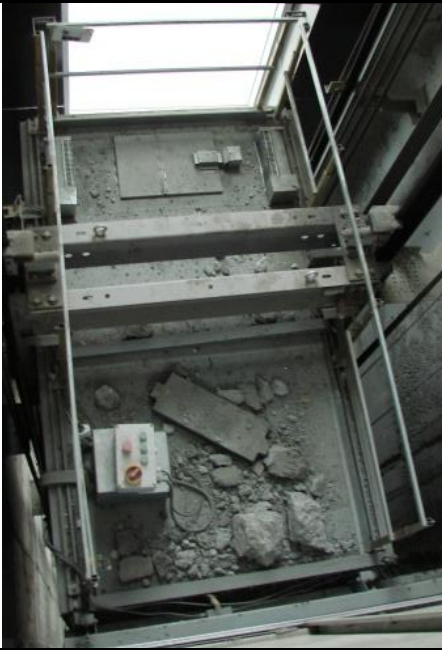
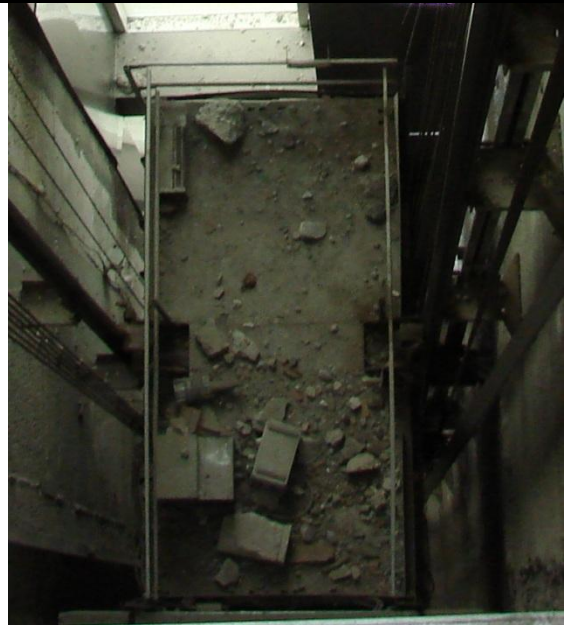
- Falling of counterweight slices on the car has been observed and reported as frequently encountered problem.
- As a result of our research and interviews with elevator servicing firms, traction machines haven't moved over their beam.

**Counterweight slice / bricks fall on the car**

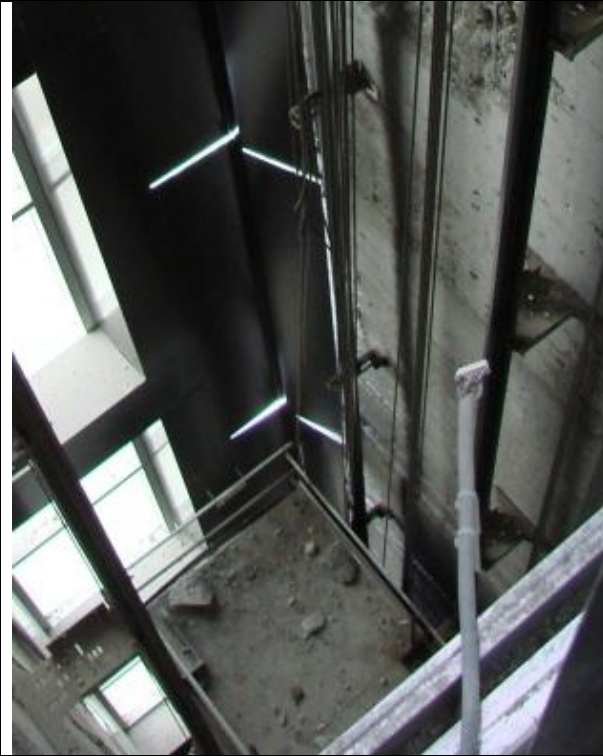
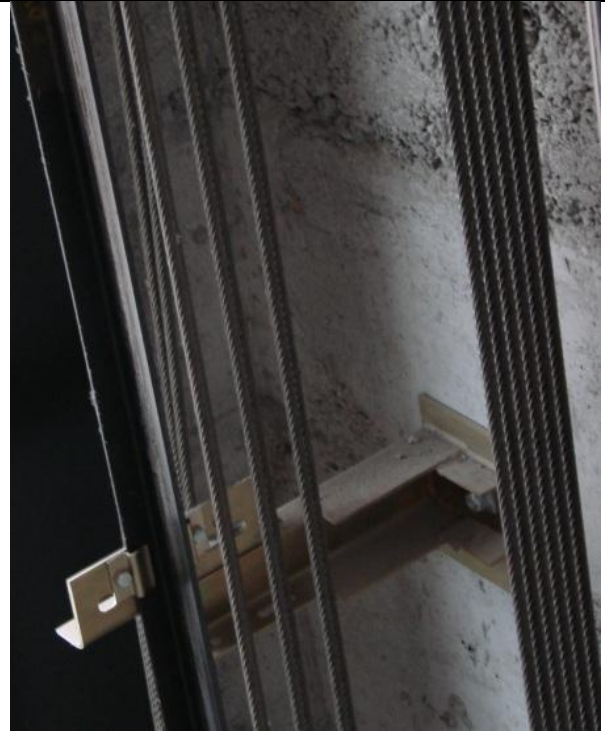
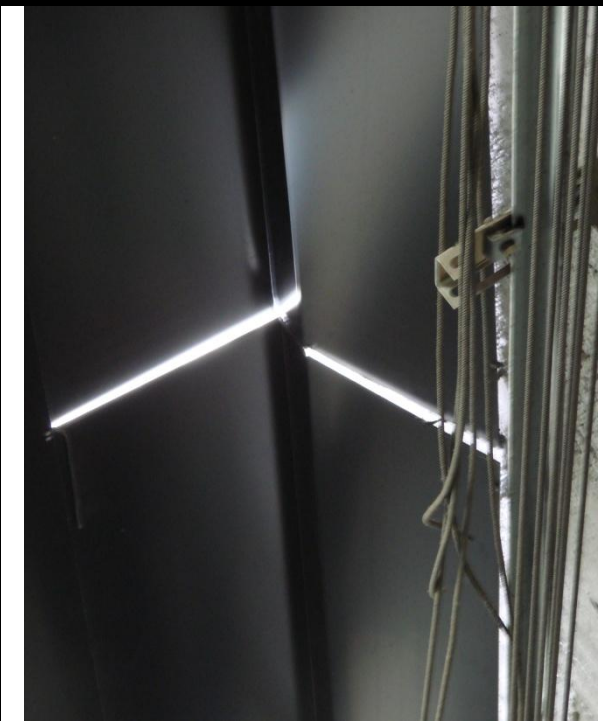
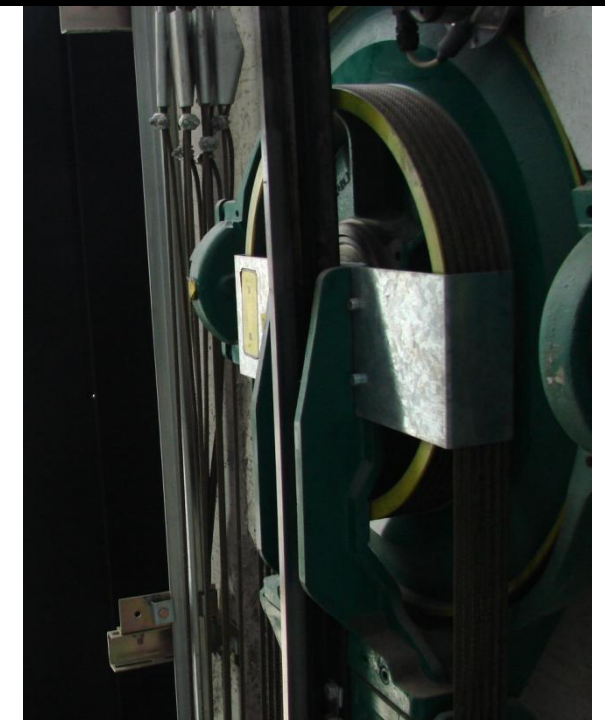
- In some cases, hauling ropes are hanged out to guide rail brackets and supporting beams.
- No damages have been observed amongst the examined hydraulic elevators or reported by the interviewed servicing firms.

### Hauling ropes damages

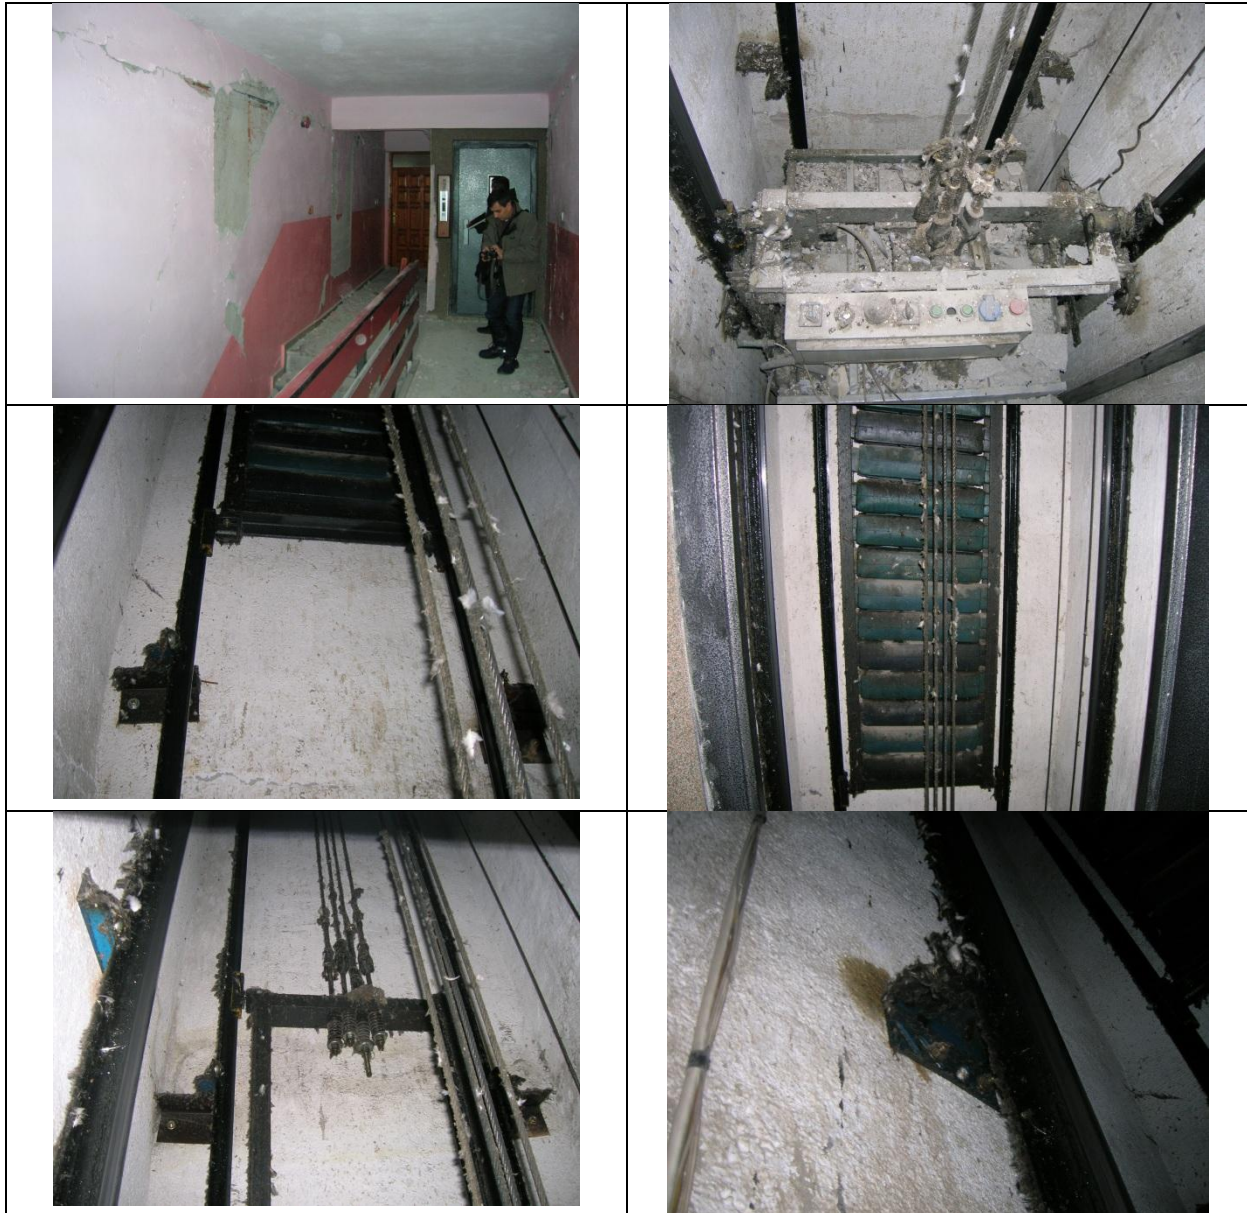
| <u>Observations :</u><br>Counterweight frame out of its rails<br>Broken guide shoes of counterweight frame<br>Loose safety gear trigger rope<br>Landing doors were safe and in operation<br>Counterweight was at above position. | |

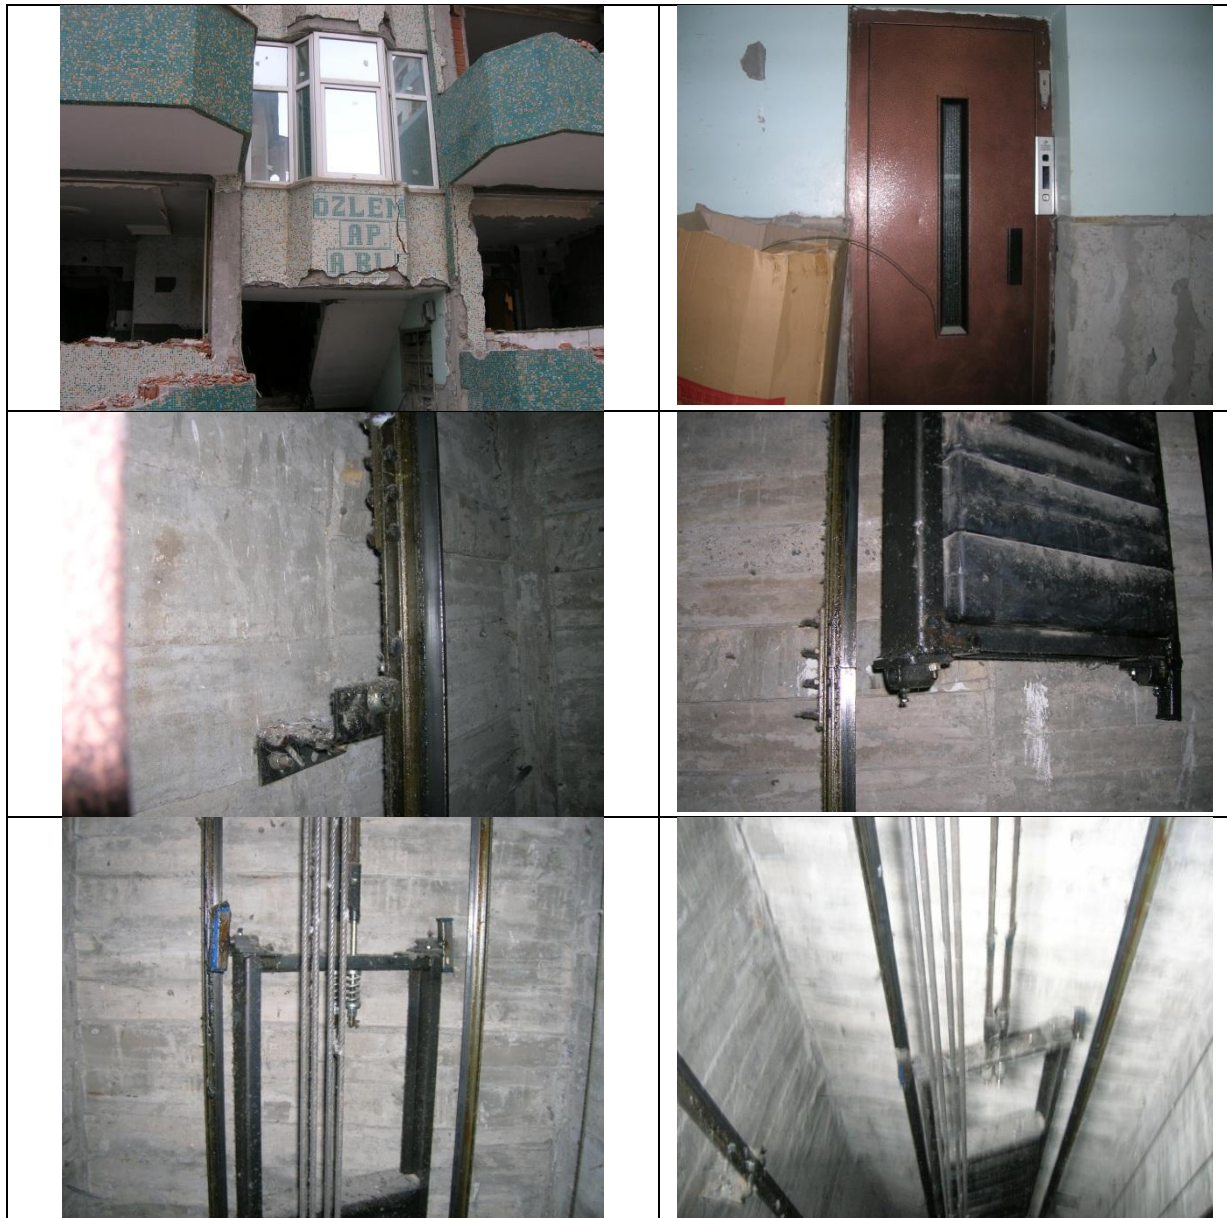
| <u>Observations :</u><br>Counterweight frame out of its rails<br>Broken guide shoes of counterweight frame<br>Rail brackets broken or damaged<br>Landing doors were safe and in operation<br>Counterweight was at above position. | |

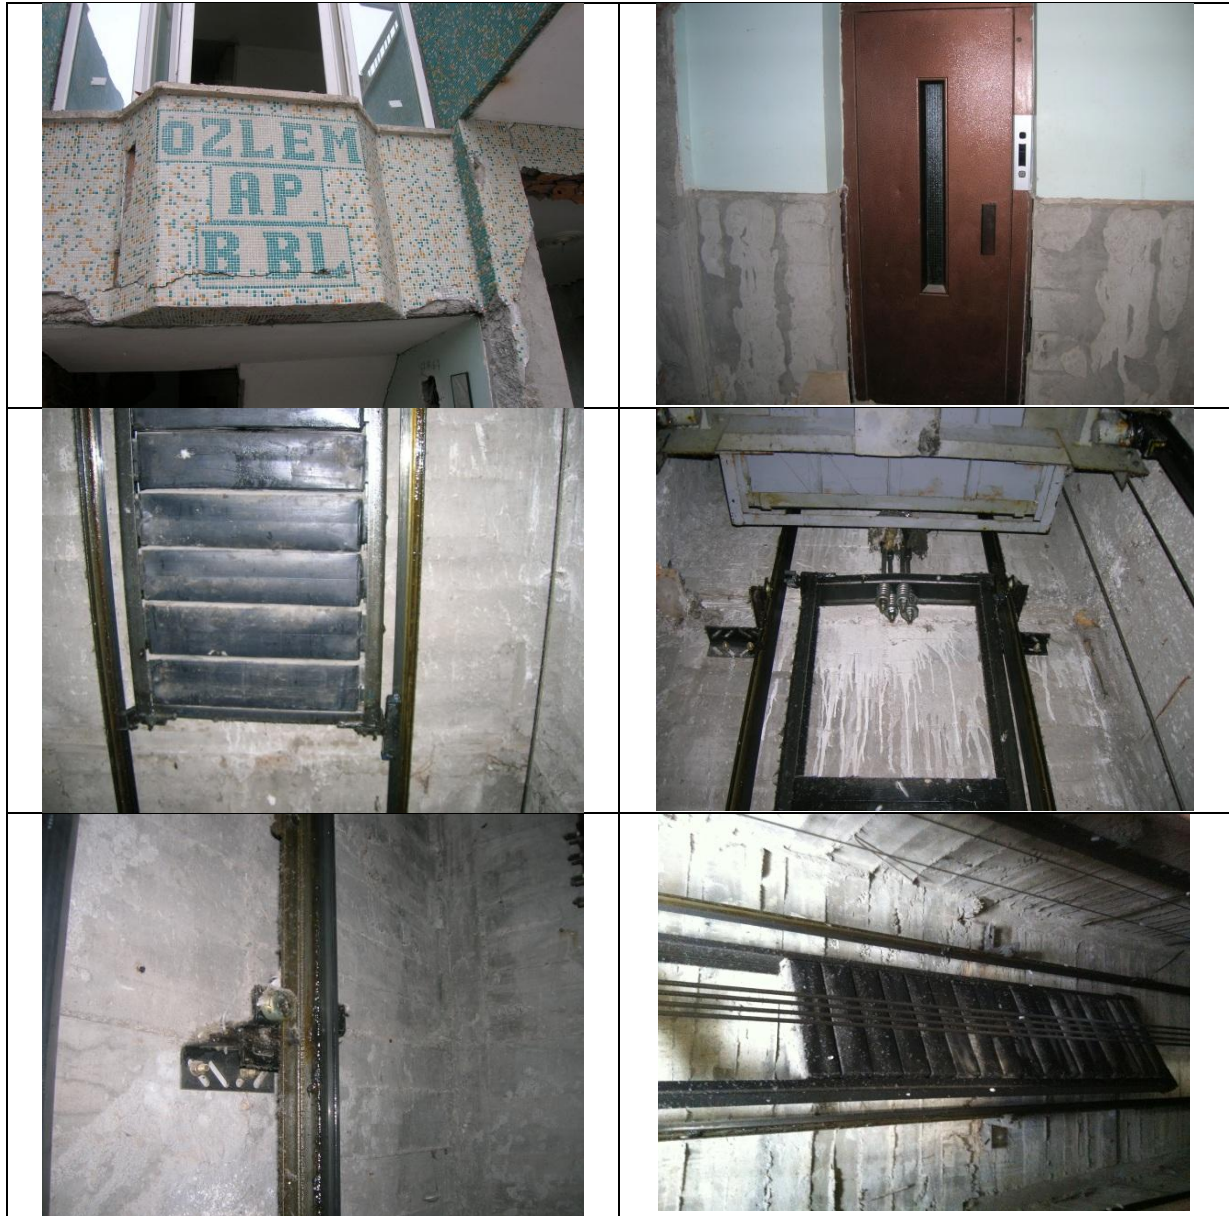
| <u>Observations :</u><br>Counterweight frame out of its rails<br>Broken guide shoes of counterweight frame<br>Rail brackets broken or damaged<br>Landing doors were safe and in operation<br>Counterweight was at above position. | |

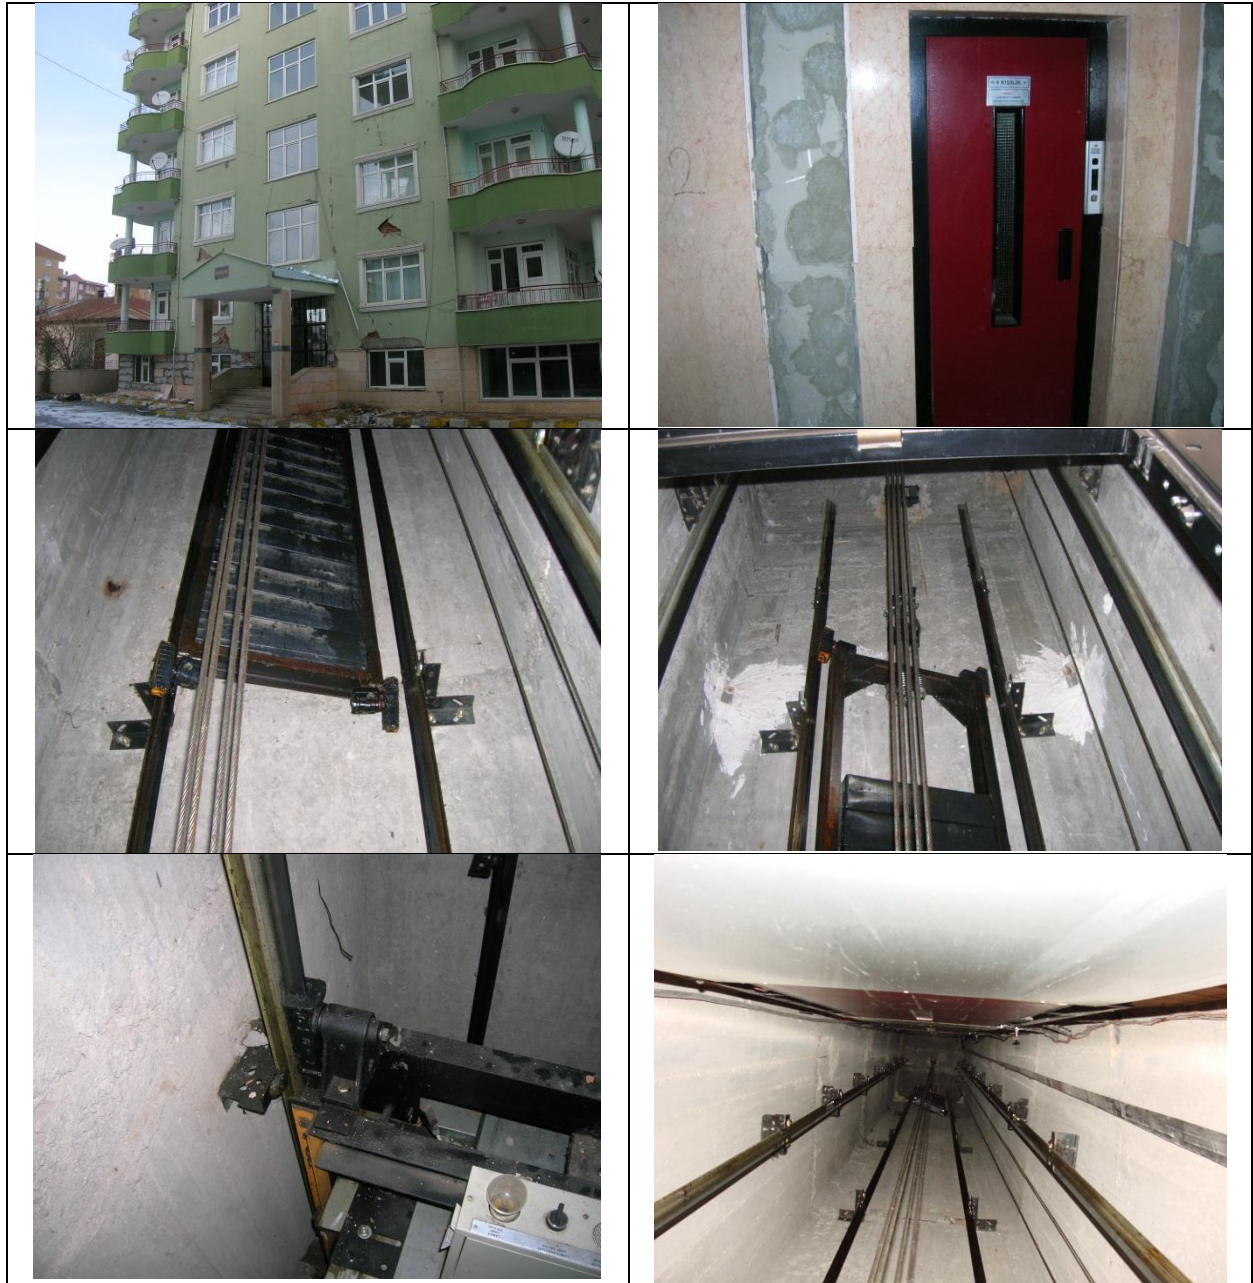
| <u>Observations :</u><br>Counterweight frame out of its rails<br>Landing doors were safe and in operation<br>Counterweight was at above position. | |

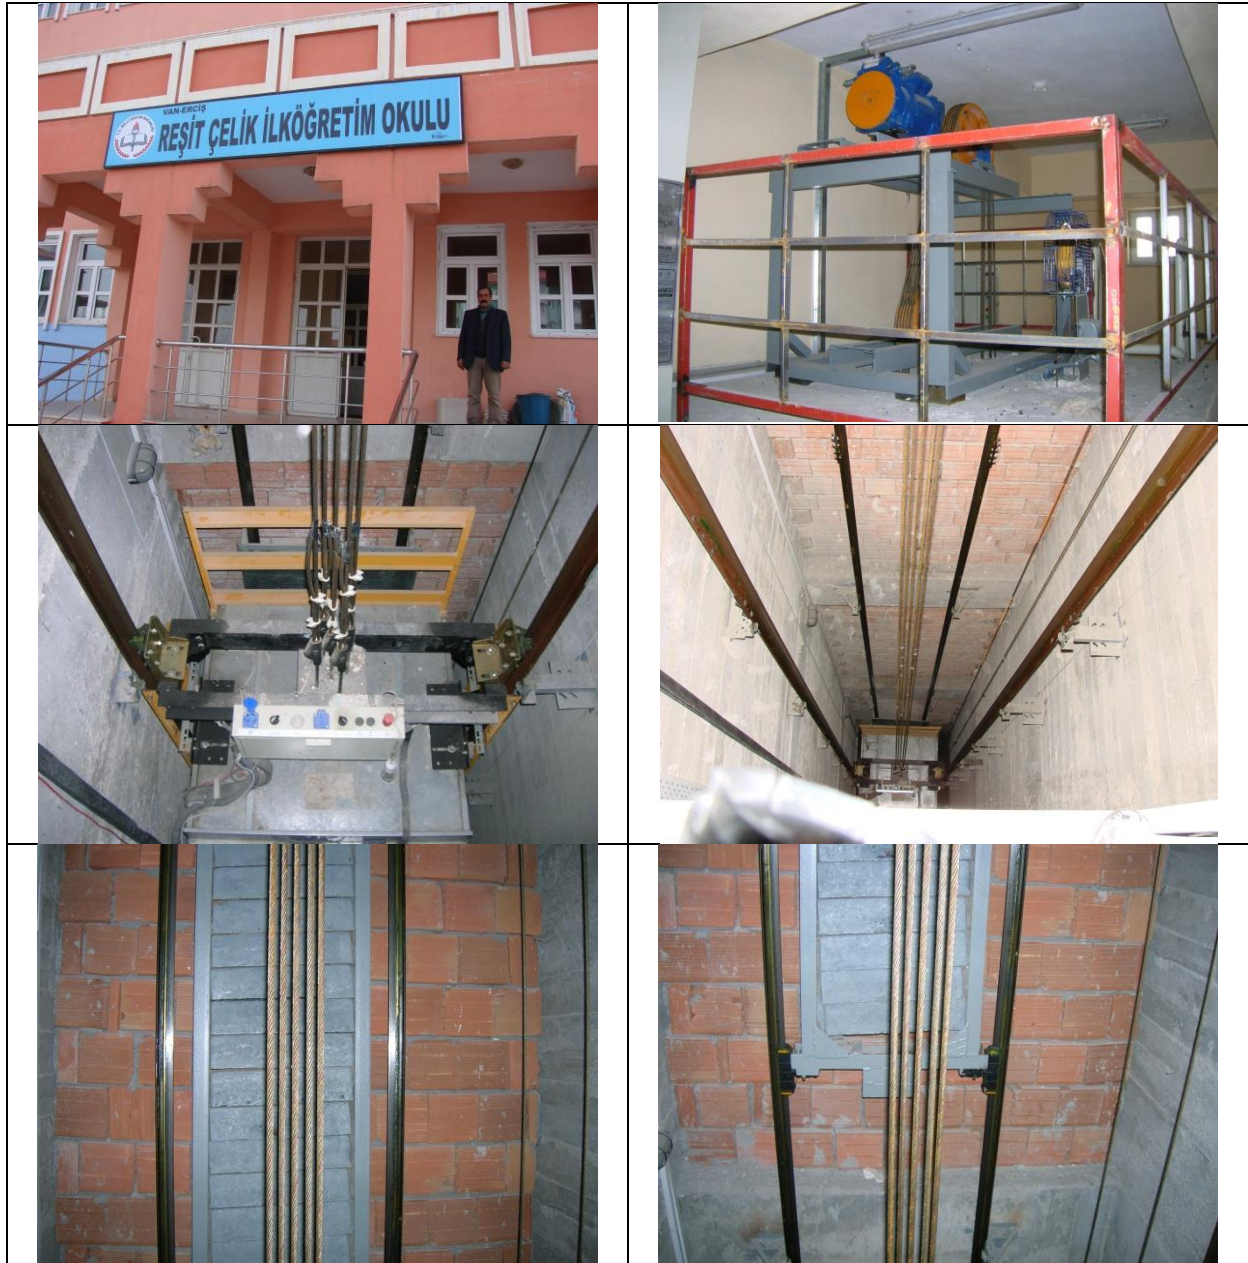
| <u>Observations :</u><br>Counterweight rails damaged. | |

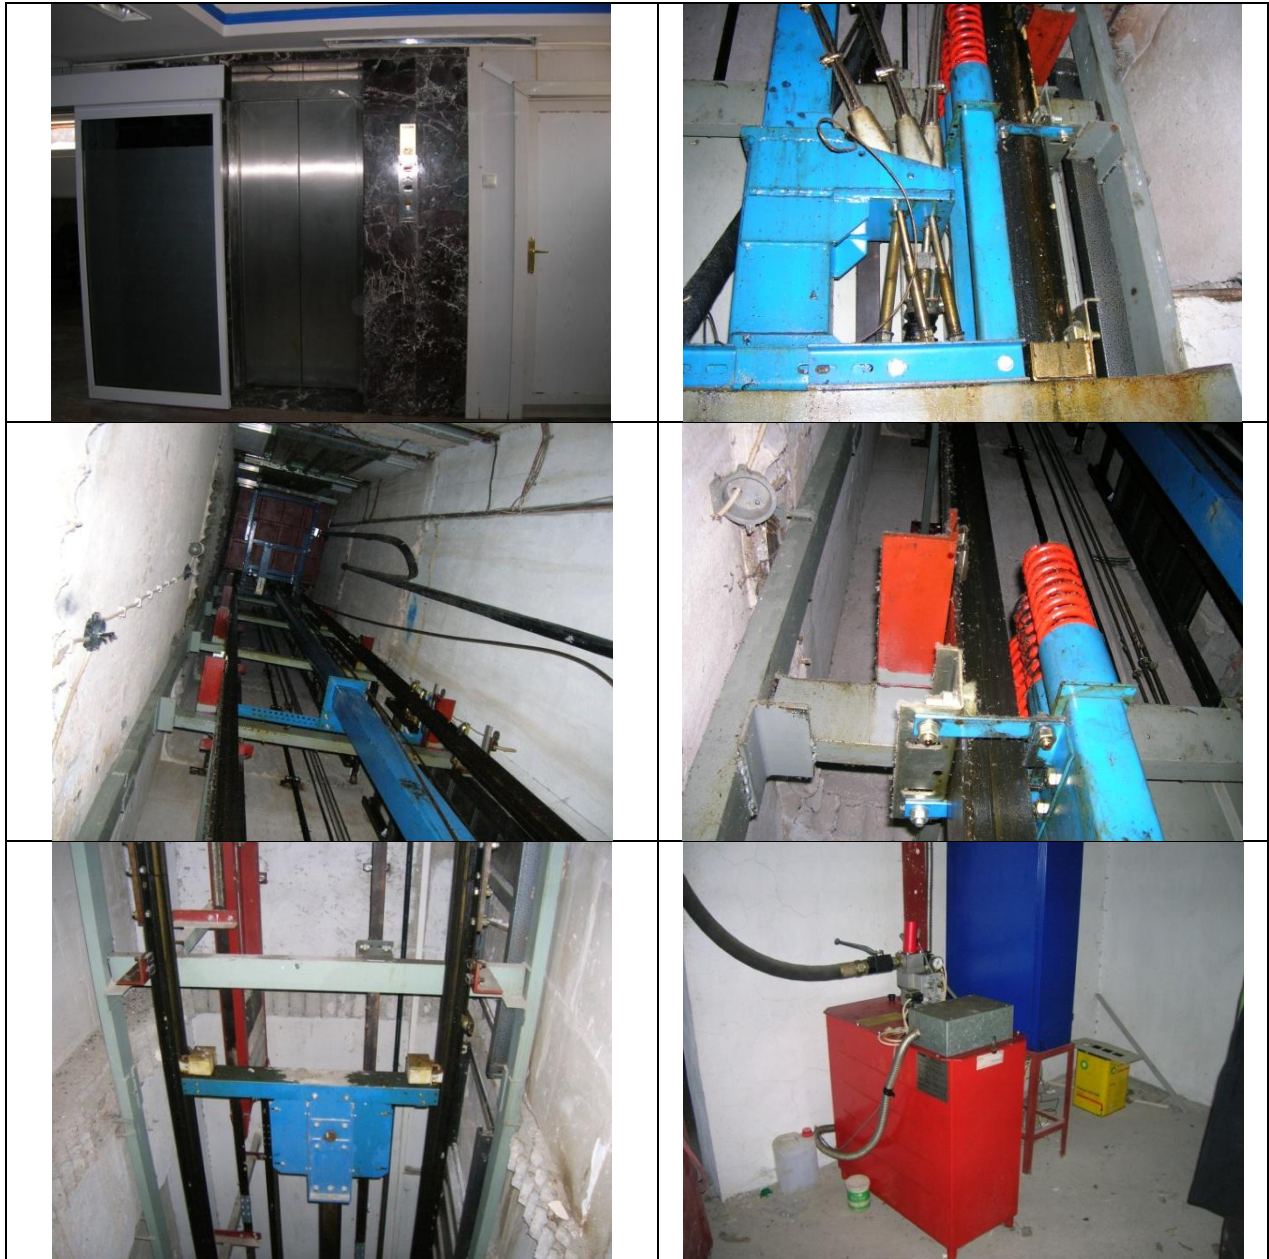
| <u>Observations :</u><br>No observed damage.<br>Safety gear engaged<br>It was out-of-service before the earthquakes. | |

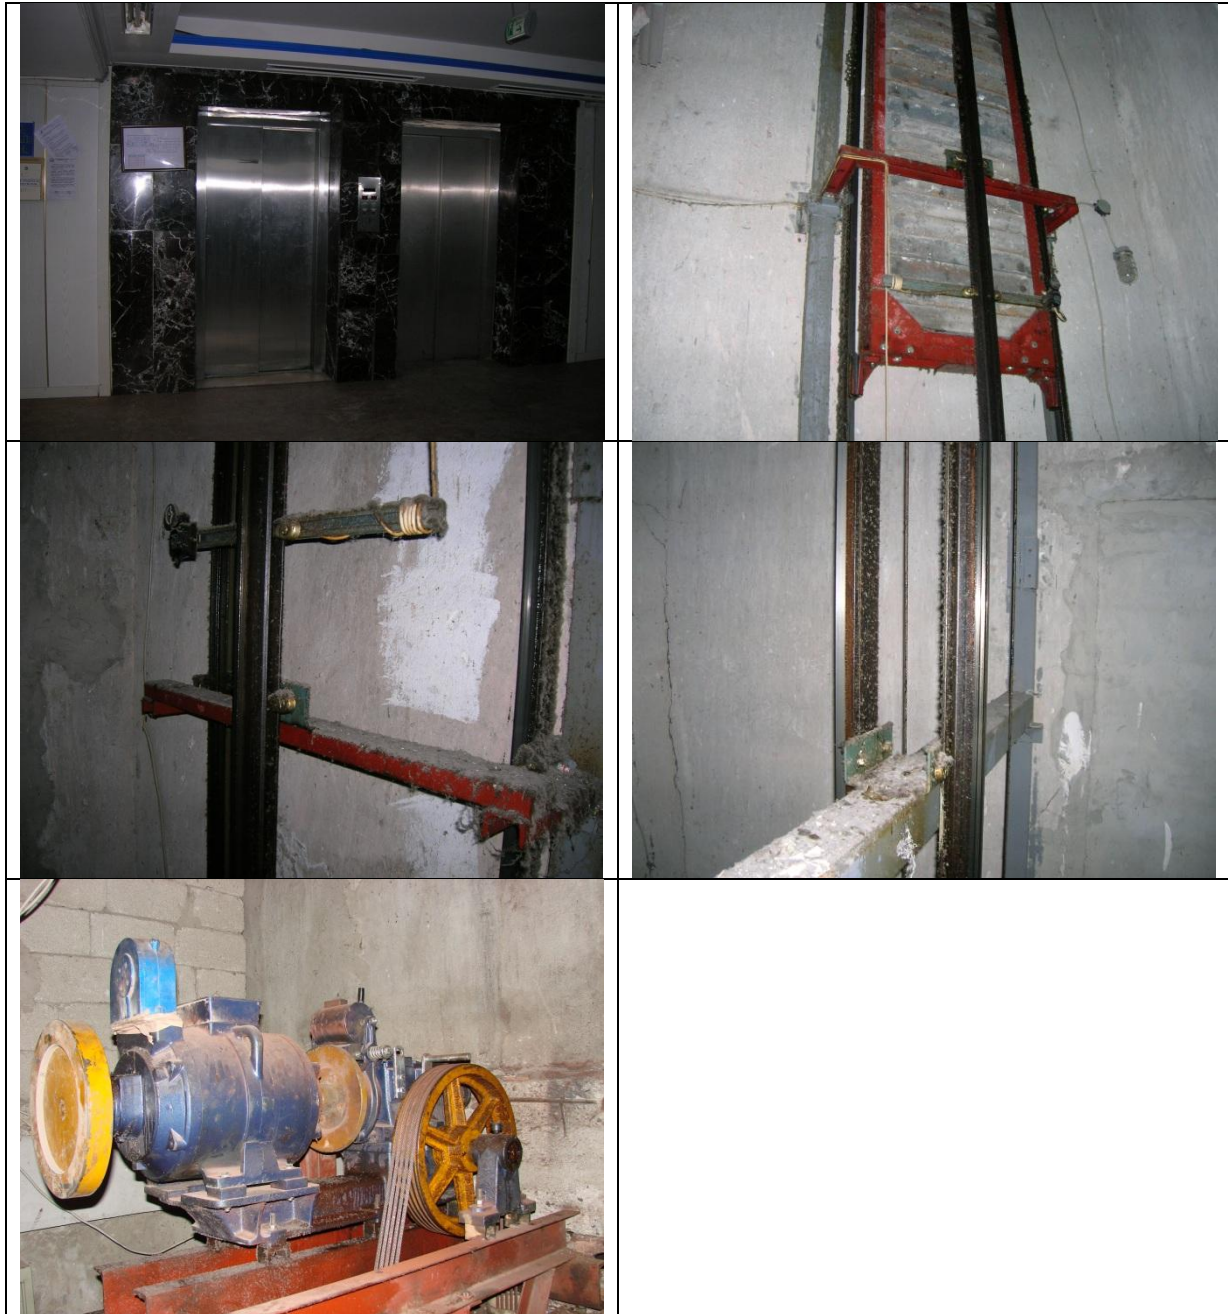
| <b>Observations :</b><br>No damage in the well.<br>Landing doors had problems | |

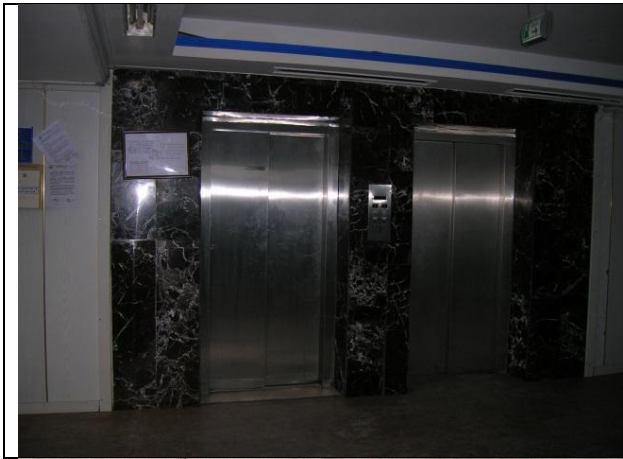
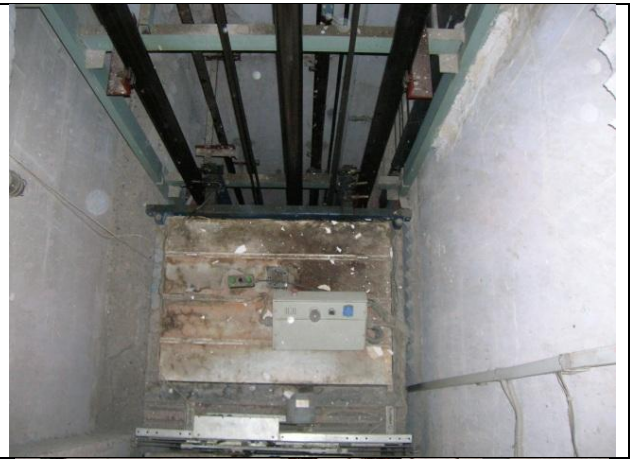
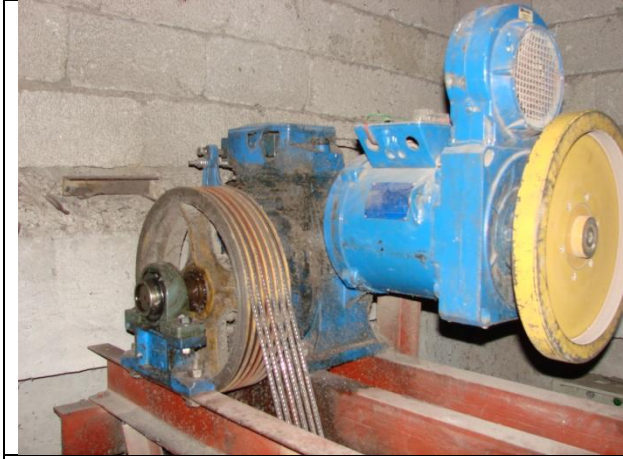
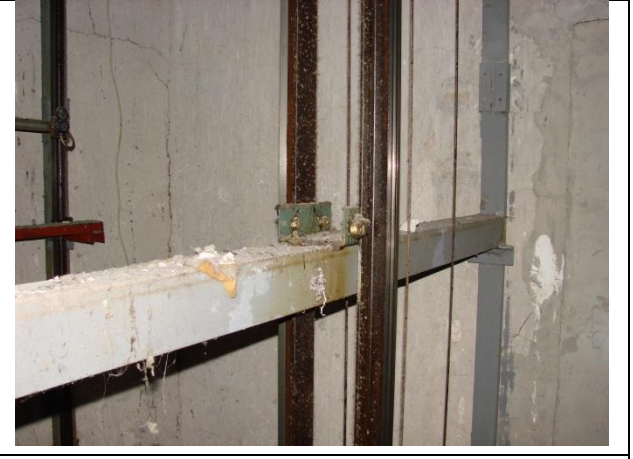
| <u>Observations :</u><br>No damage in the well.<br>Landing doors had problems | |

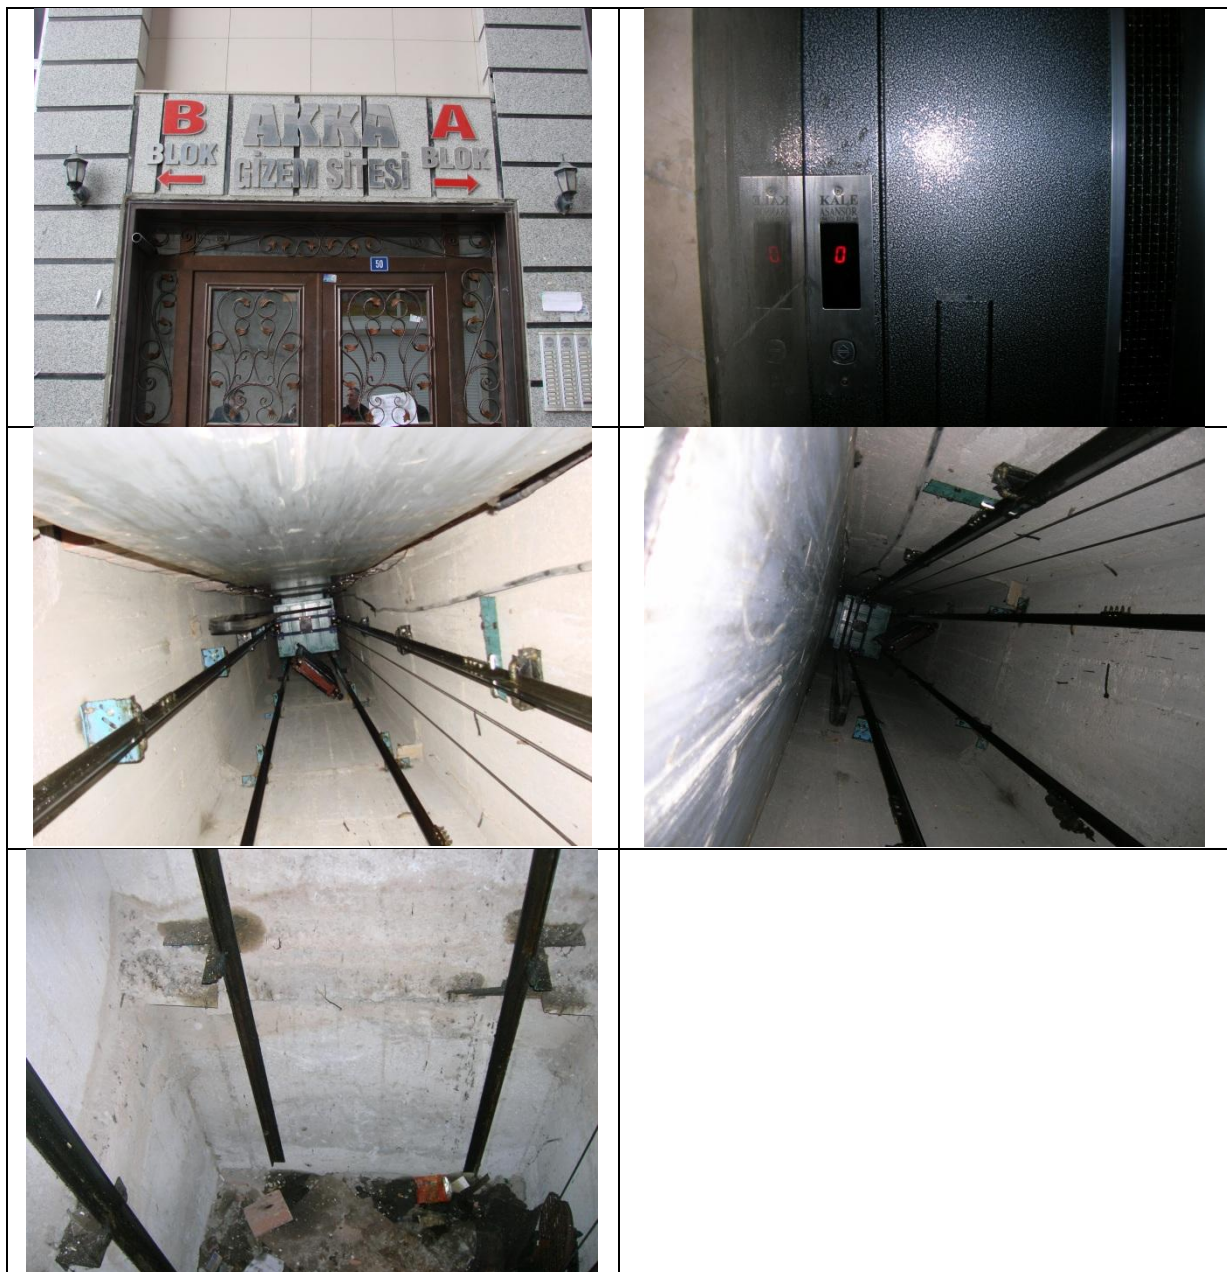
Rail brackets damaged.

Landing doors were safe and in operation

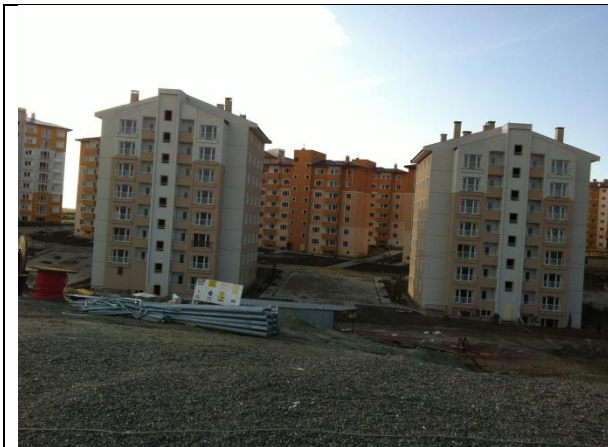
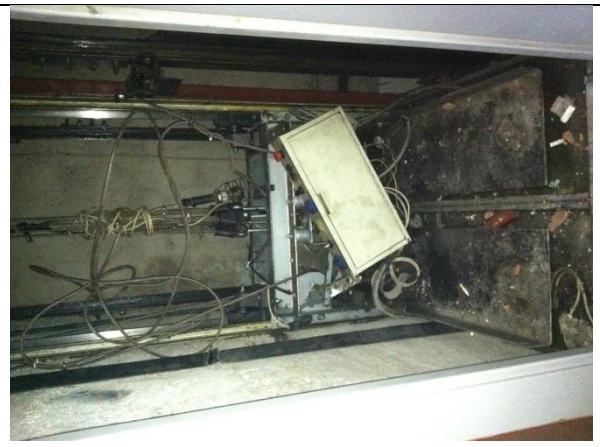
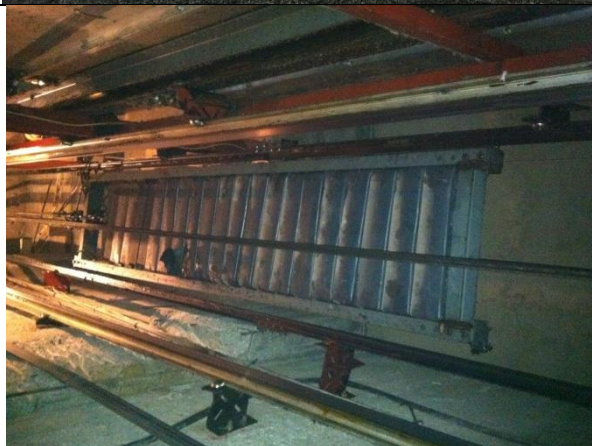
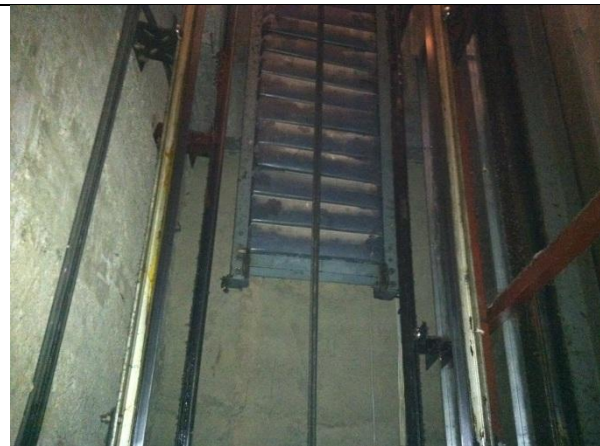
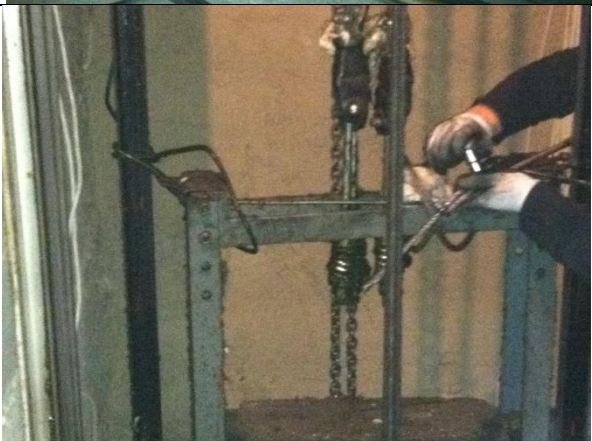
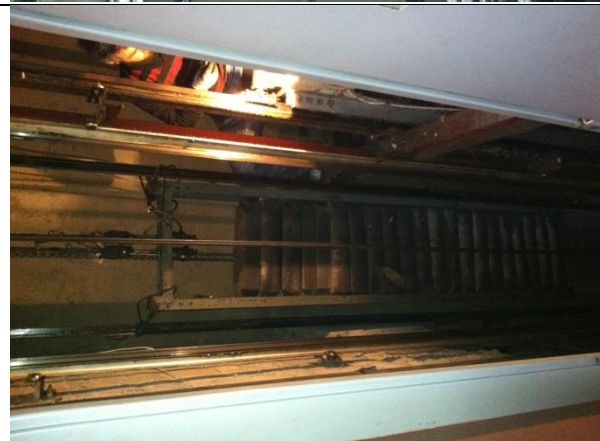
| <u>Observations :</u><br>Counterweight was below the car.<br>Counterweight frame out of its rails<br>Broken guide shoes of counterweight frame<br>Landing doors were safe and in operation | |

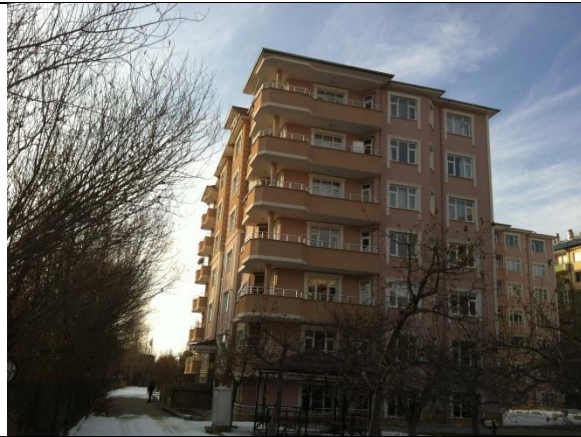
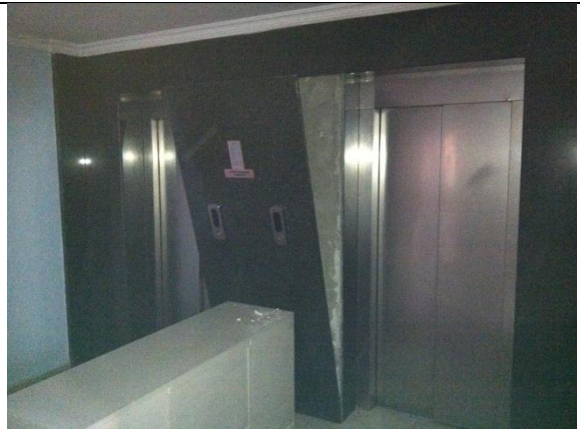
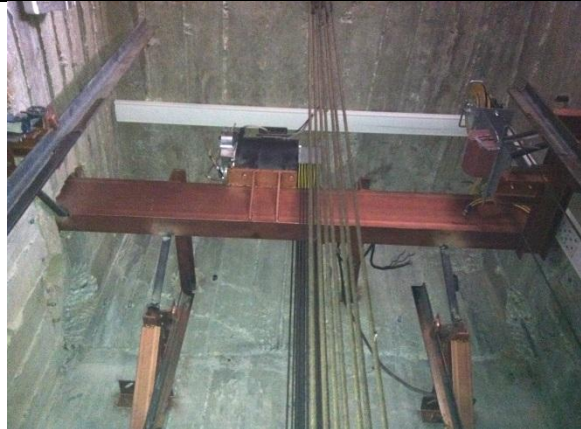
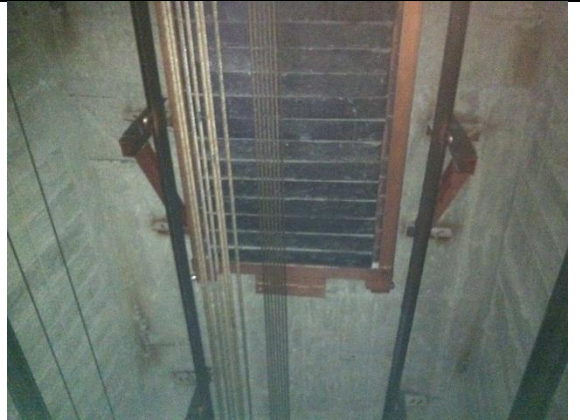
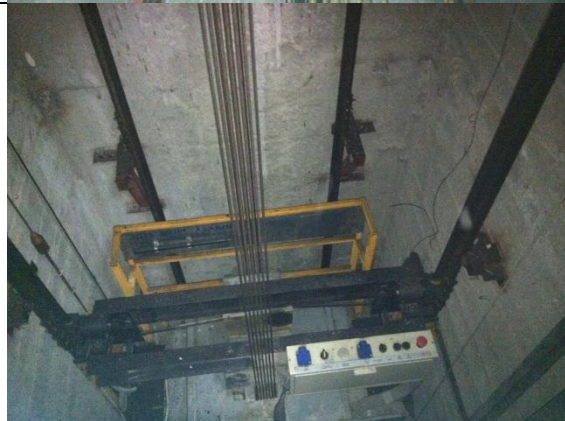
| <u>Observations :</u><br>Counterweight was below the car.<br>Counterweight frame out of its rails<br>Broken guide shoes of counterweight frame | |
