# **A survey for the effect of 2011 Van earthquakes on elevators**

**Prepared by  
Professor C.E.İmrak**

**January 2012**

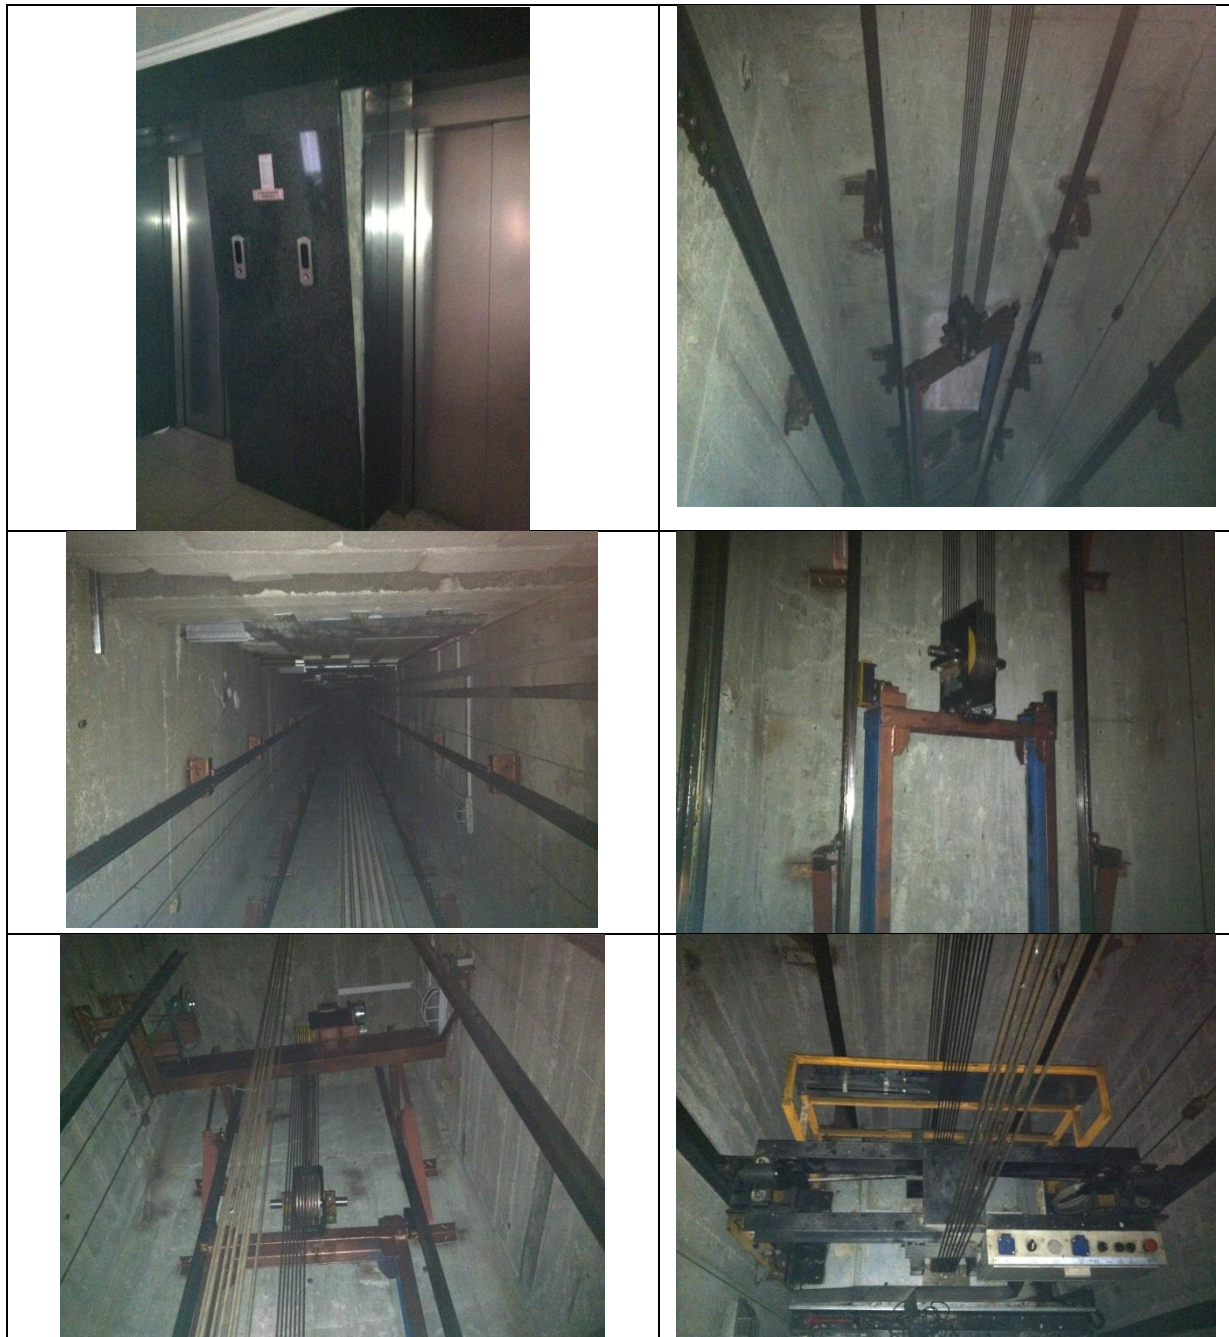
| <u>Observations :</u><br>Counterweight was below the car.<br>Counterweight frame out of its rails<br>Broken guide shoes of counterweight frame | |

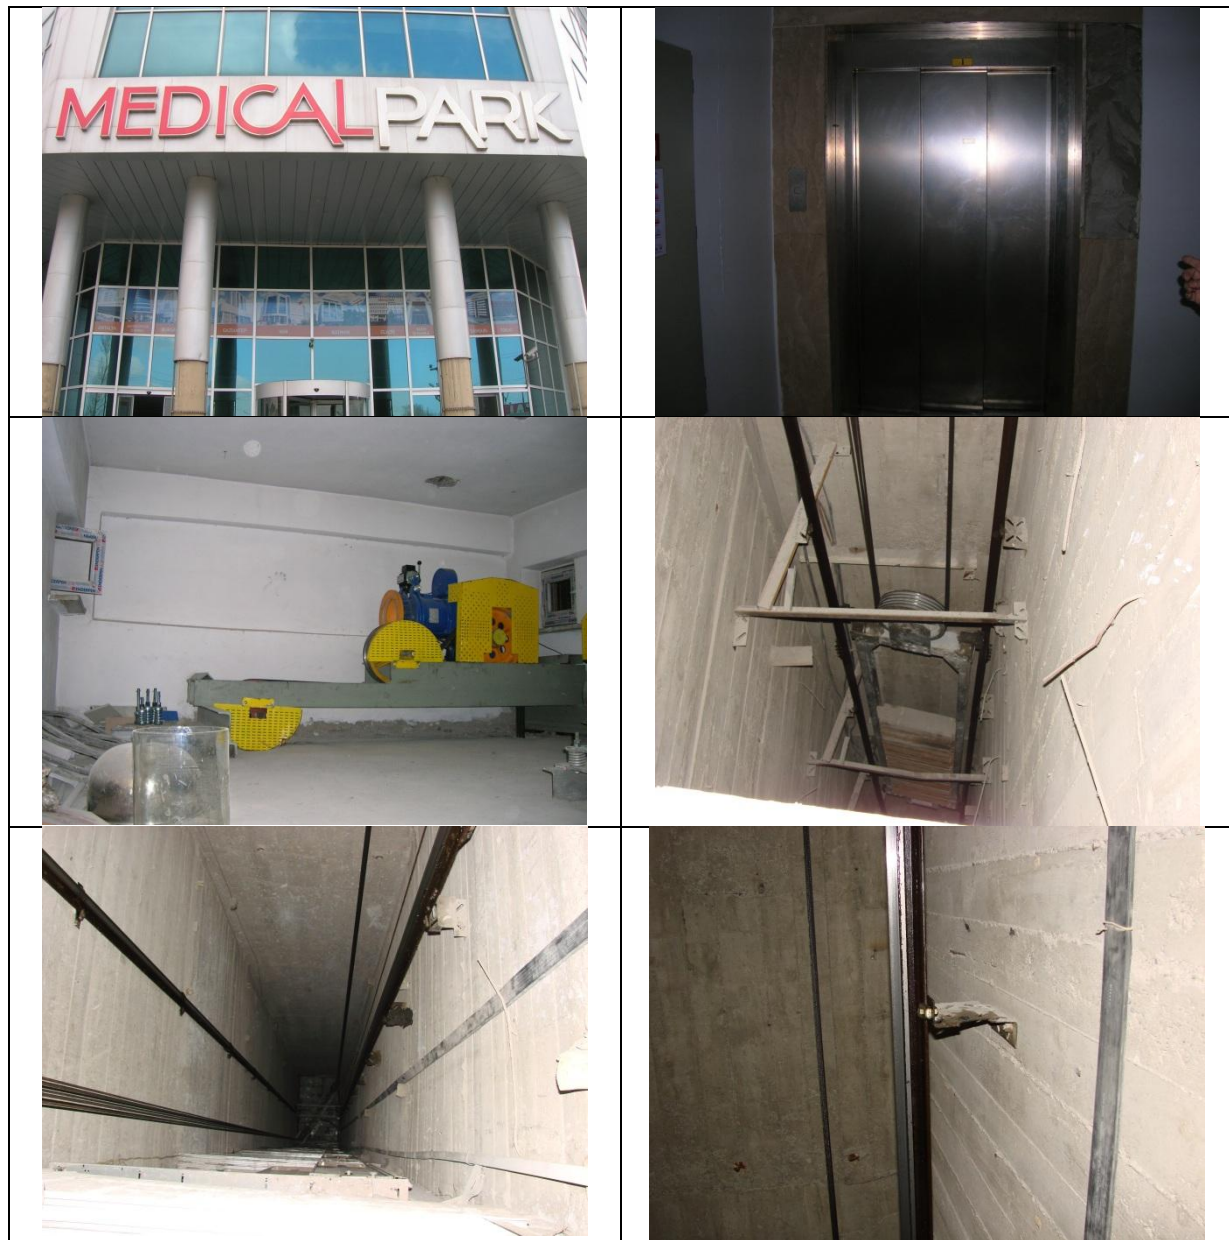
| <u>Observations :</u><br>Counterweight frame out of its rails<br>Landing doors had problems | |

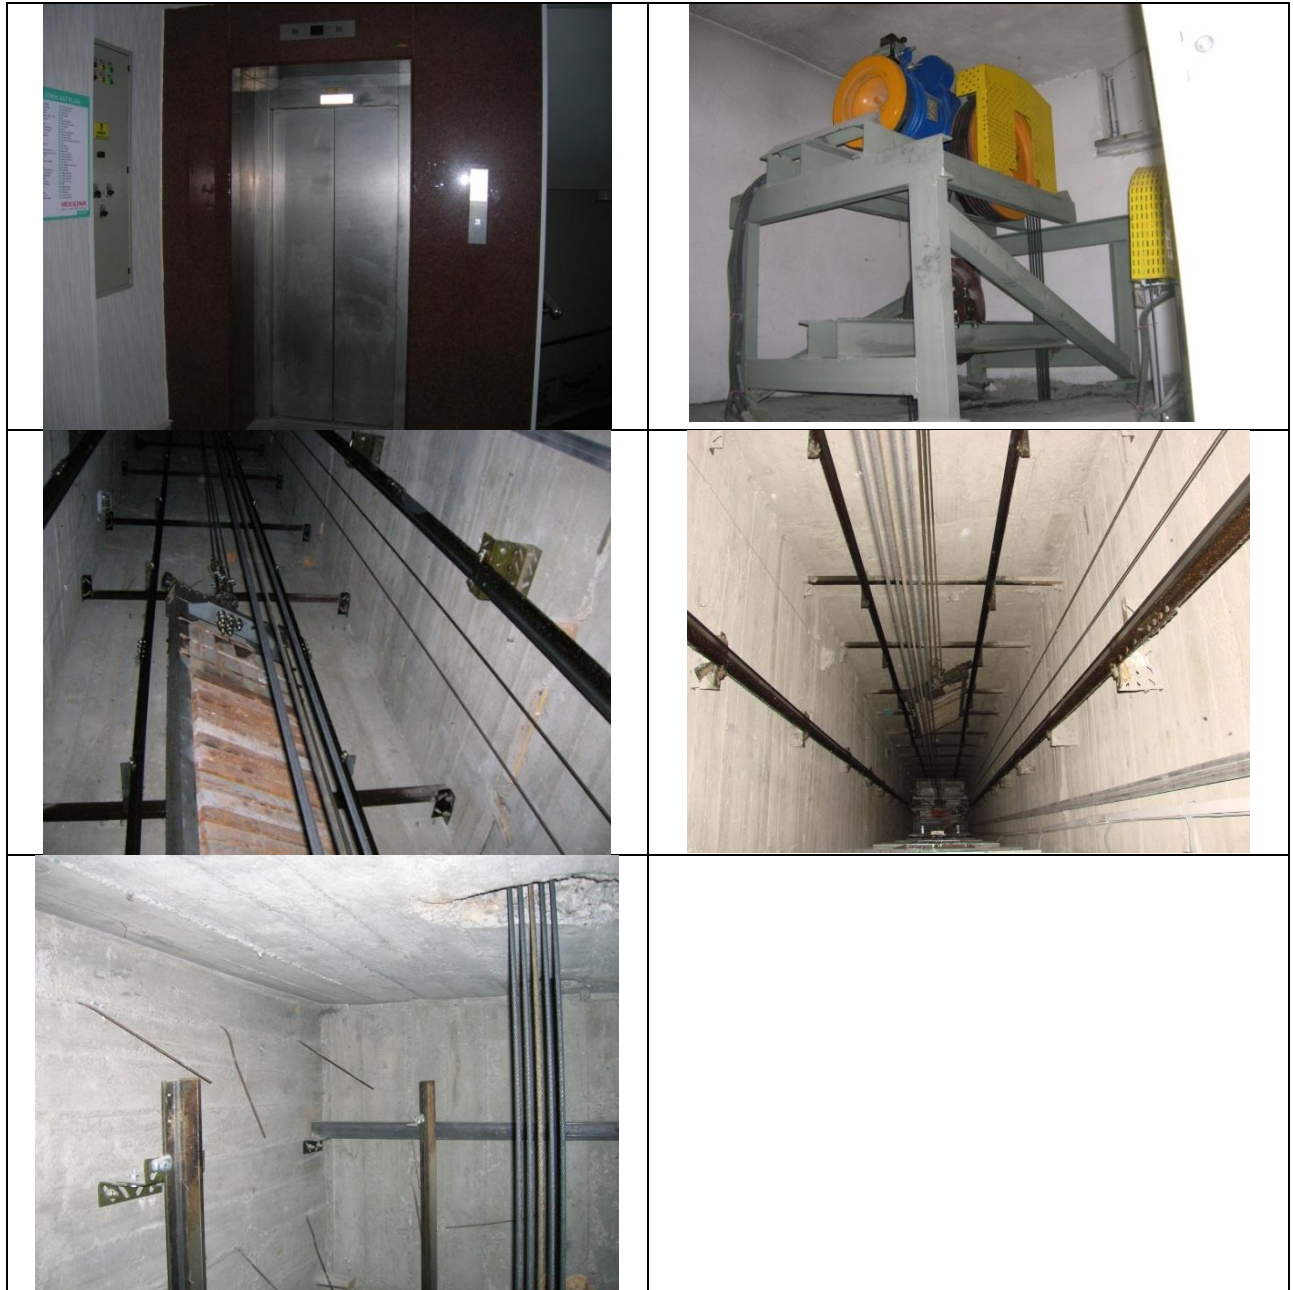
| <u>Observations :</u><br>Counterweight frame out of its rails | |

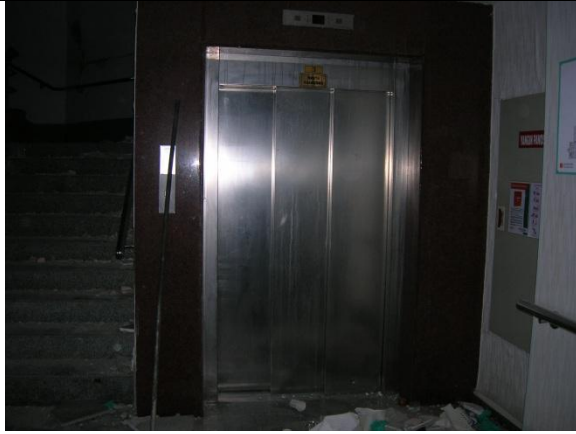
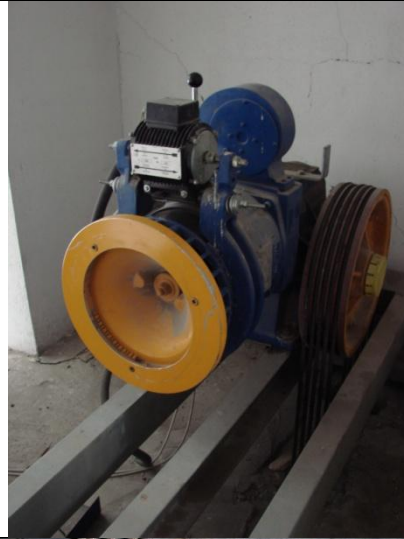
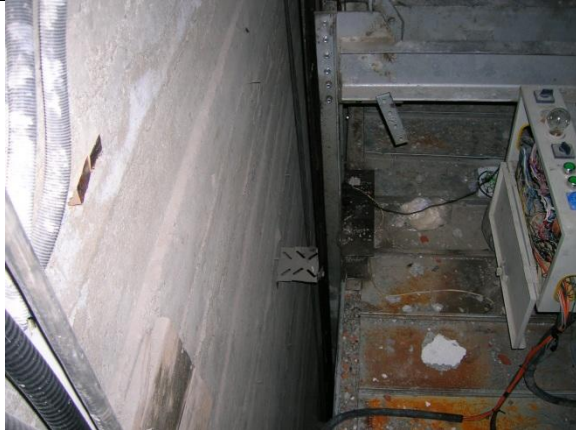
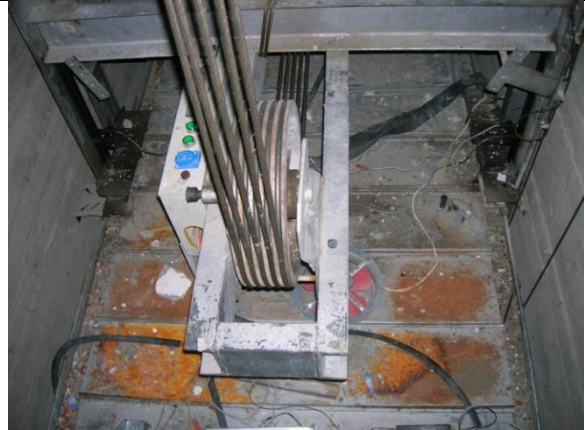
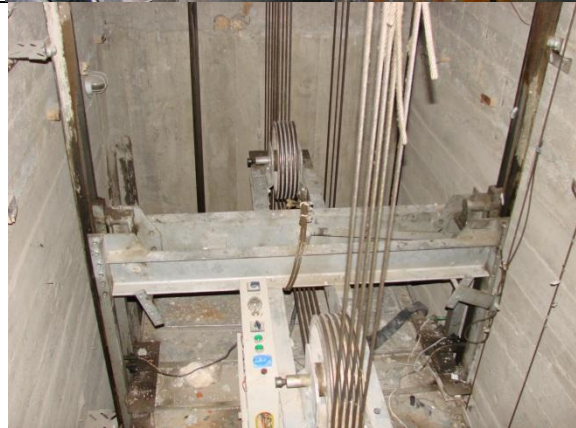
| <u>Observations :</u><br>Counterweight was out of it rails. Repaired after the first quake. | |

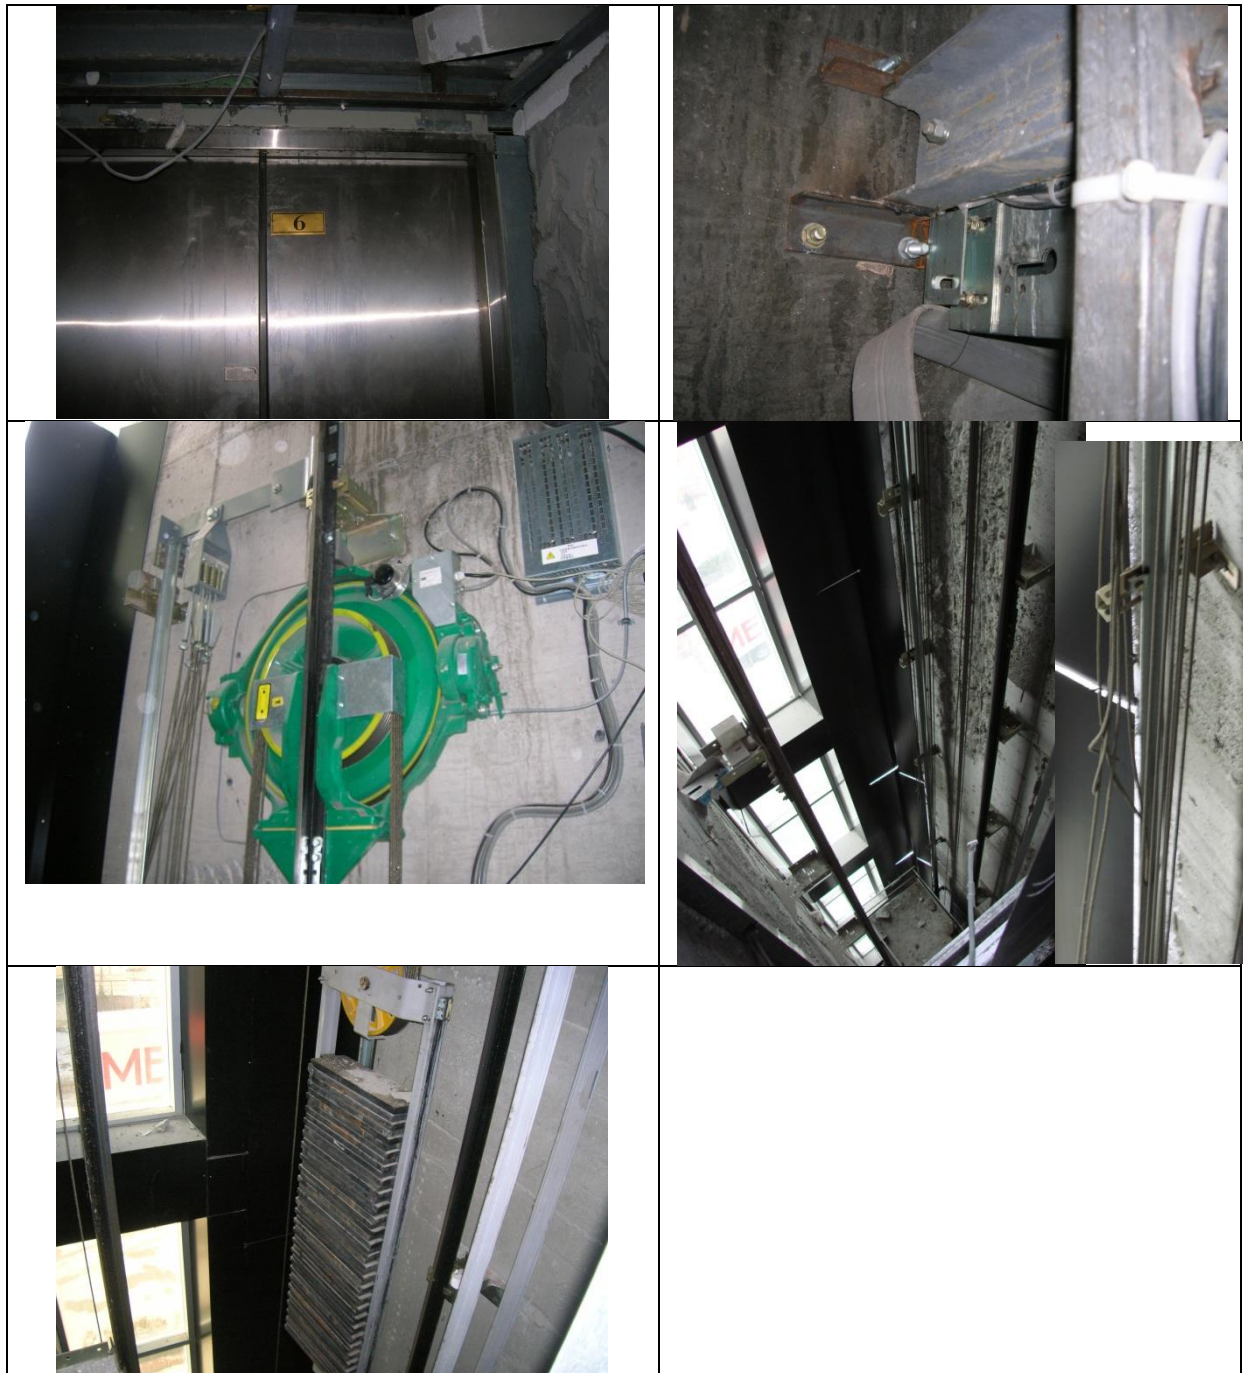
| <u>Observations :</u><br>Counterweight frame out of its rails.<br>Landing doors jammed and had problems<br>Ropes broken and hanging out on brackets. | |
