# **A survey for the effect of 2011 Van earthquakes on elevators**

**Prepared by  
Professor C.E.İmrak**

**January 2012**

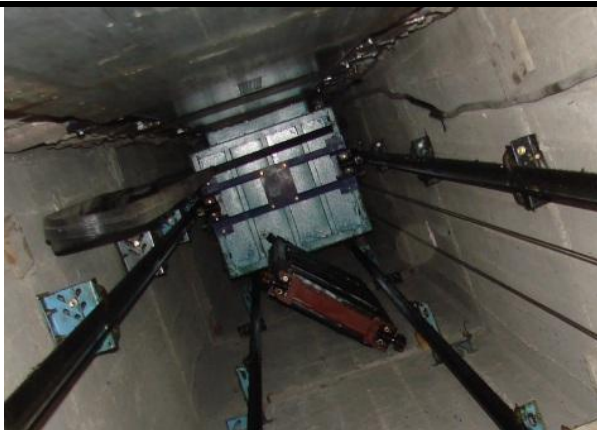
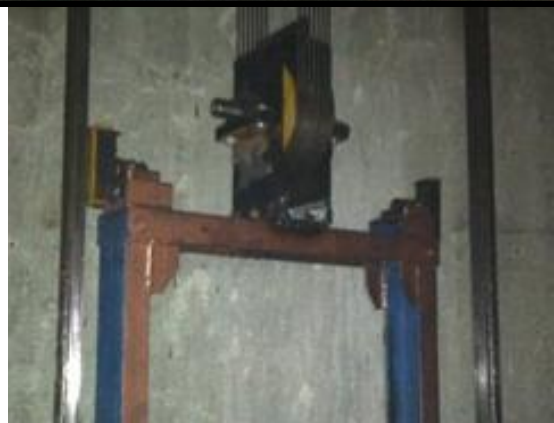
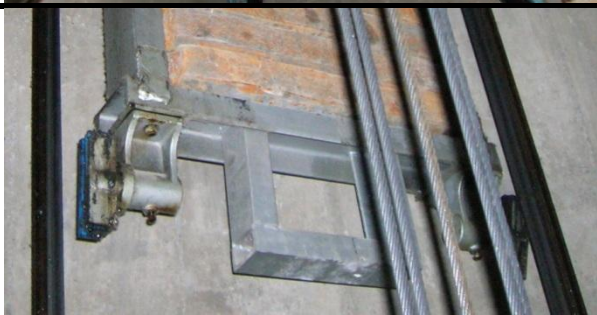
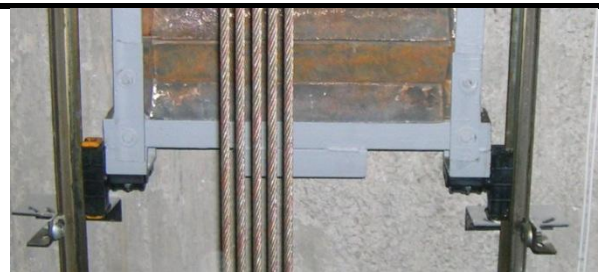
Counterweights out of their guide rails

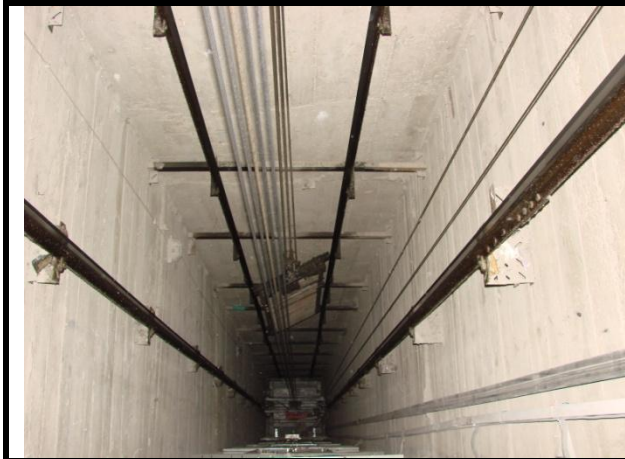
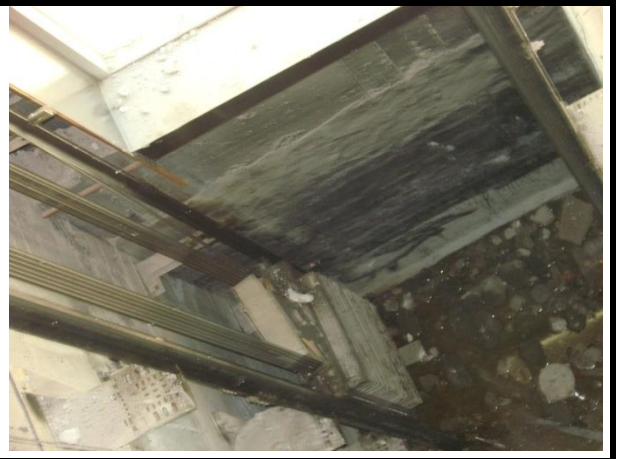
**Counterweight frame bent**

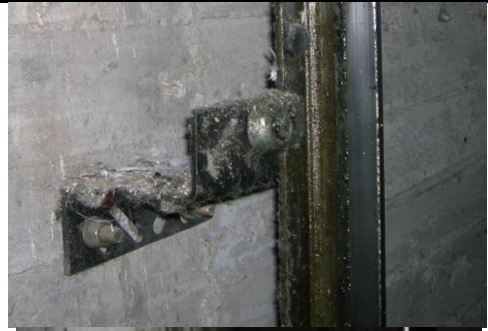
**Counterweight slice / bricks fall on the car**

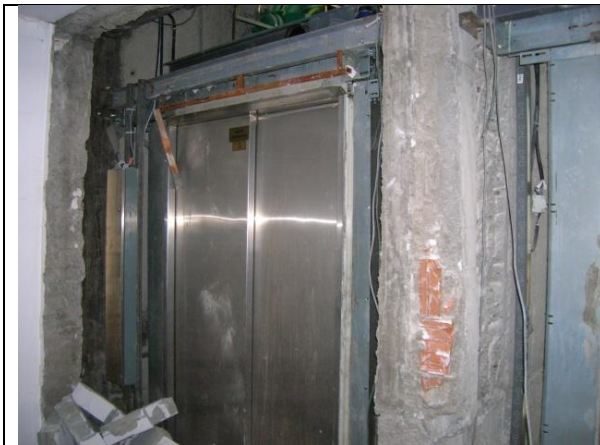
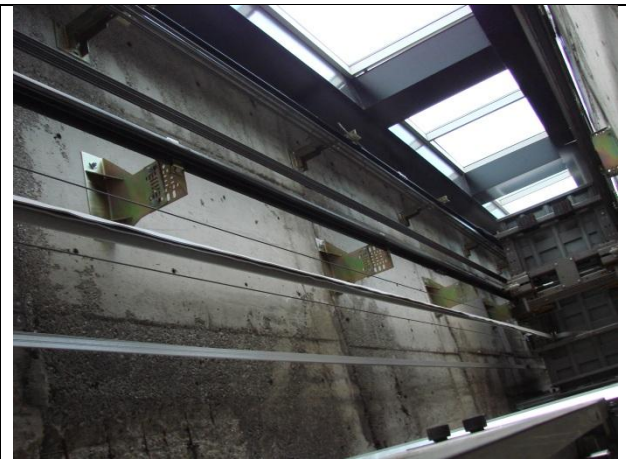
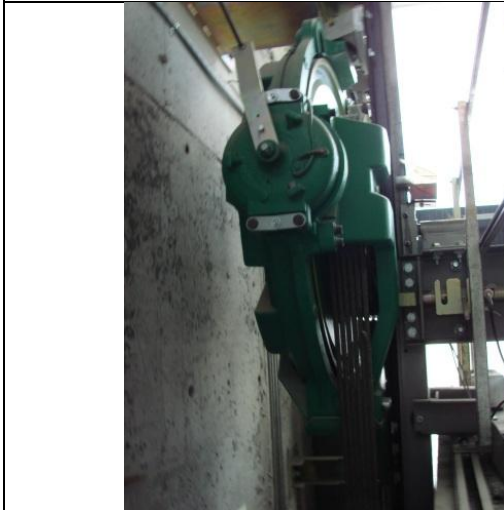
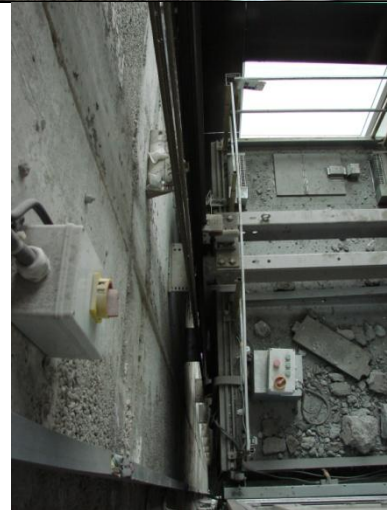
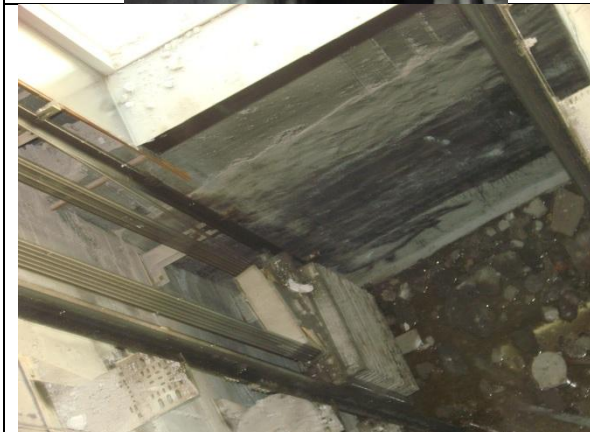
| <u>Observations :</u><br>Counterweight frame out of its rails.<br>Landing doors jammed and had problems<br>Hauling ropes hanged out on brackets | |

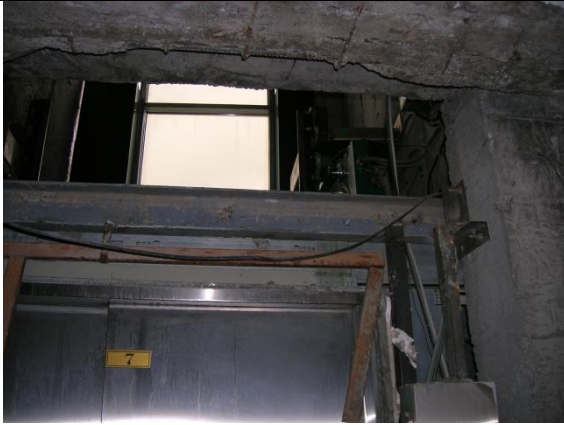
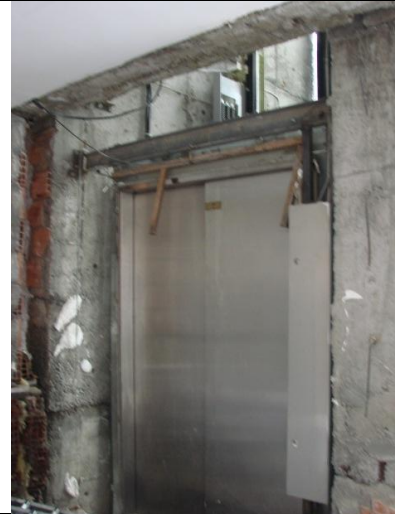
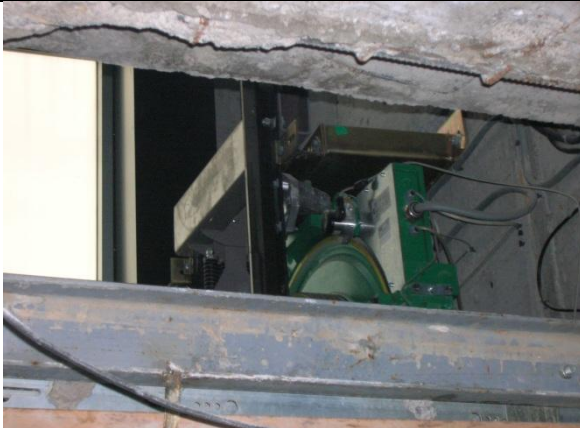
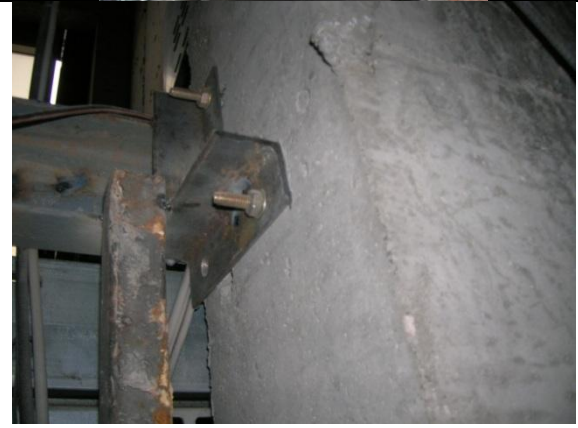
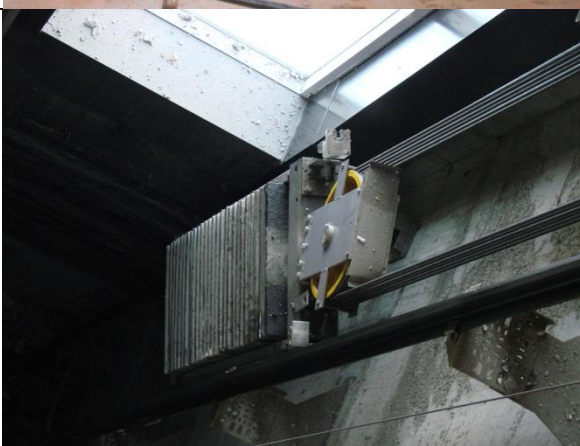
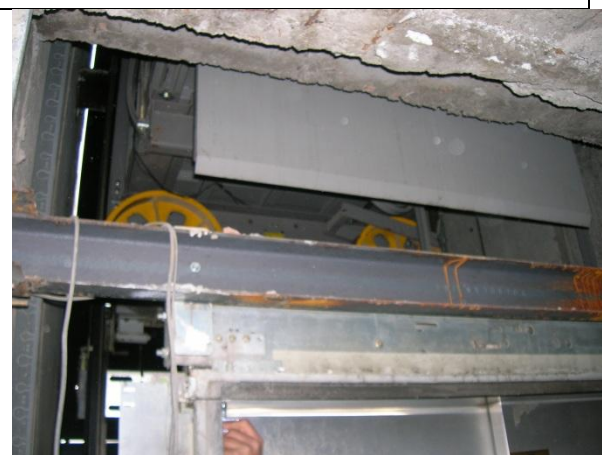
| <u>Observations :</u><br>Counterweight frame out of its rails<br>Hoisting ropes out of sheave | |
